**Federal Aviation
Administration**

ADVISORY CIRCULAR

AVIATION MAINTENANCE ALERTS

**ALERT
NUMBER
407**

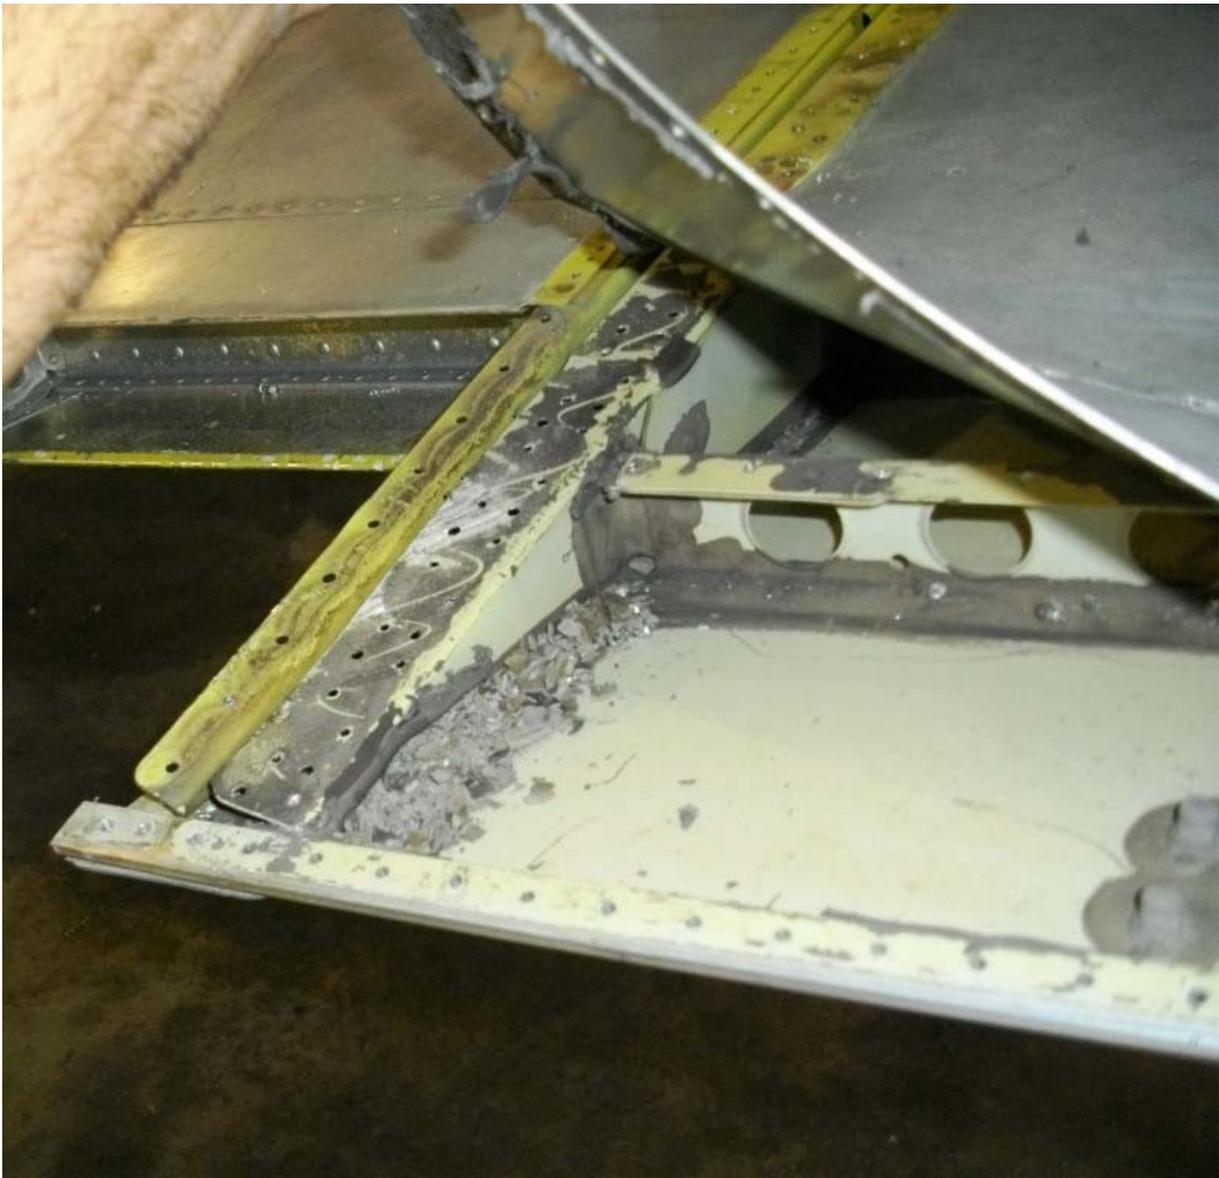
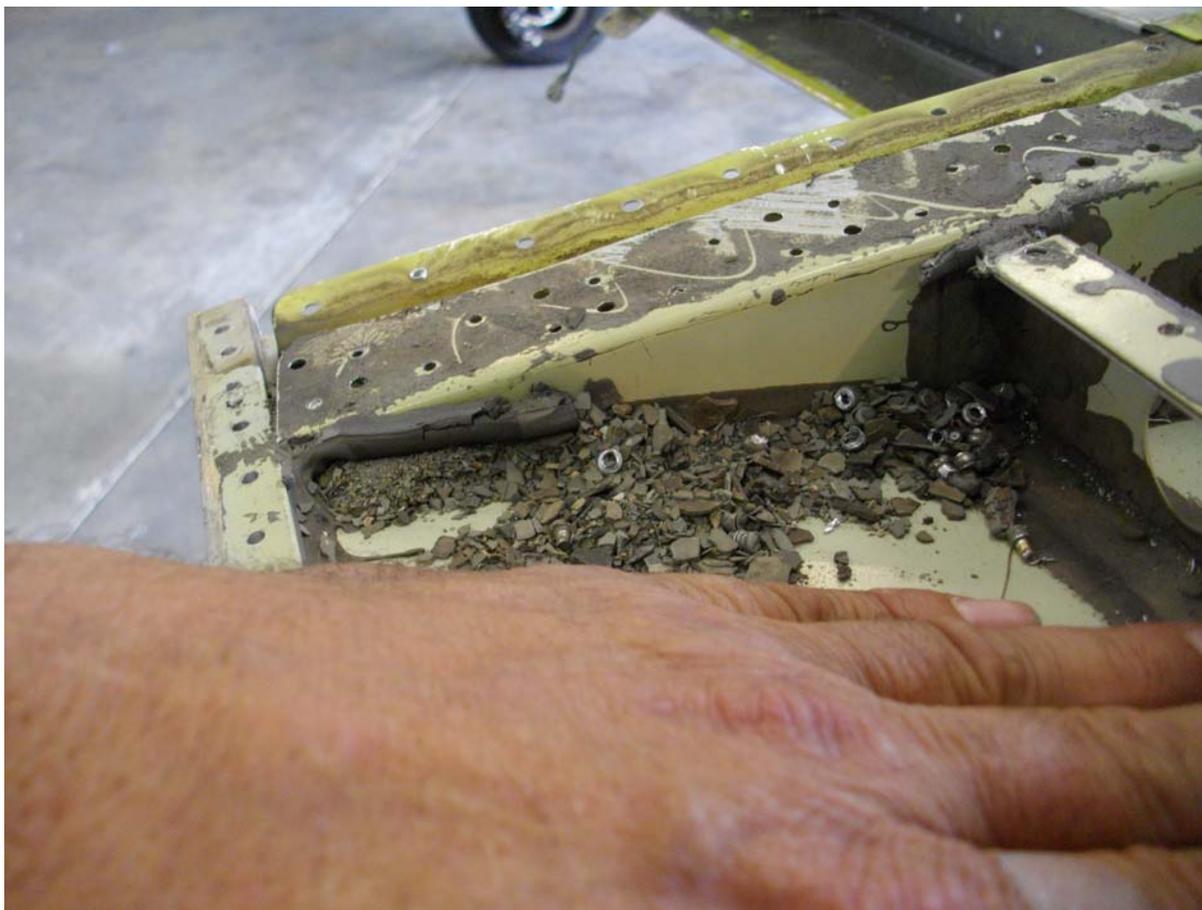
"This aircraft has factory installed, extended range fuel cells," says a mechanic. "The cells are sealed wing bays—or 'wet wing' fuel cells located in each wing tip. These wing tip fuel cells were found leaking fuel through the fuel vent tubes (P/N 60-170010) on both sides. The cause of the leak was found to be the deterioration of the sealant around the tube slip-joint fittings. Also present in the fuel cells was an excessive amount of particulate contamination. This *(debris)* is deteriorated fuel tank sealant that failed to remain bonded to the inner tank surfaces. These particles were trapped in multiple locations throughout the entire fuel storage system with no way of draining, accessing, or even *(detecting)* their presence. The upper wing skin must be removed to access the trouble areas in the wing tip fuel cell—given inadequate inspection panel locations. The addition of a second inspection panel to the aft, inboard area of the wing tip fuel cell may be necessary to *(facilitate detection)* of this discrepancy. *(This is)* a potentially dangerous condition as fuel can enter the wing vent system, or *(these particles)* may cause fuel contamination and *(engine failure)*."

(This is a fuel cell? It looks more akin to a trash dump! Thank-you for the documentation—Ed.)

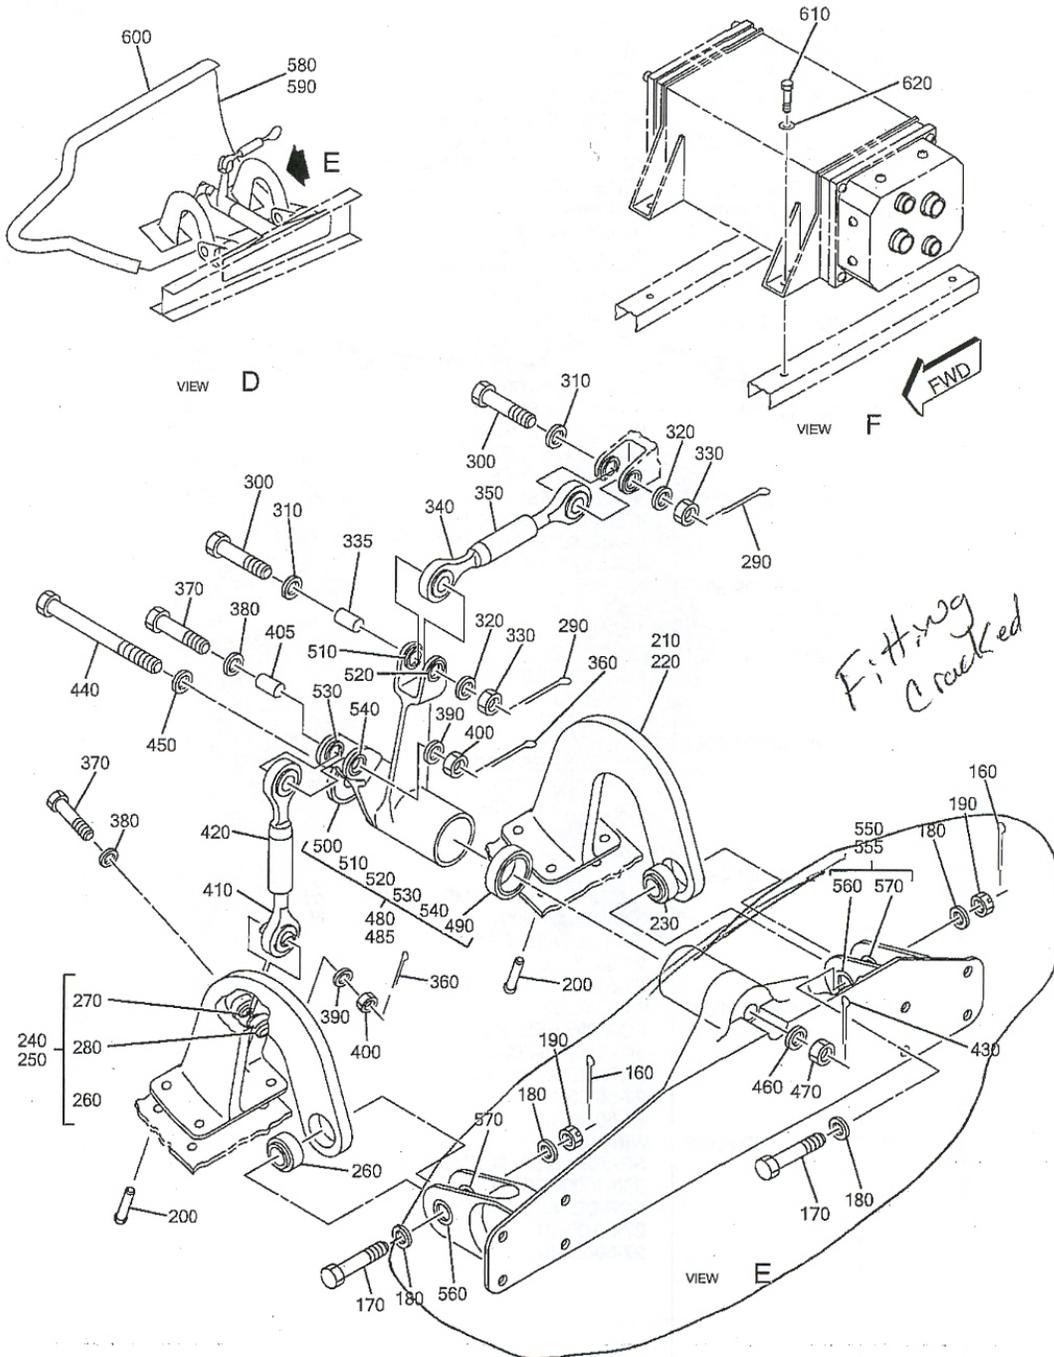
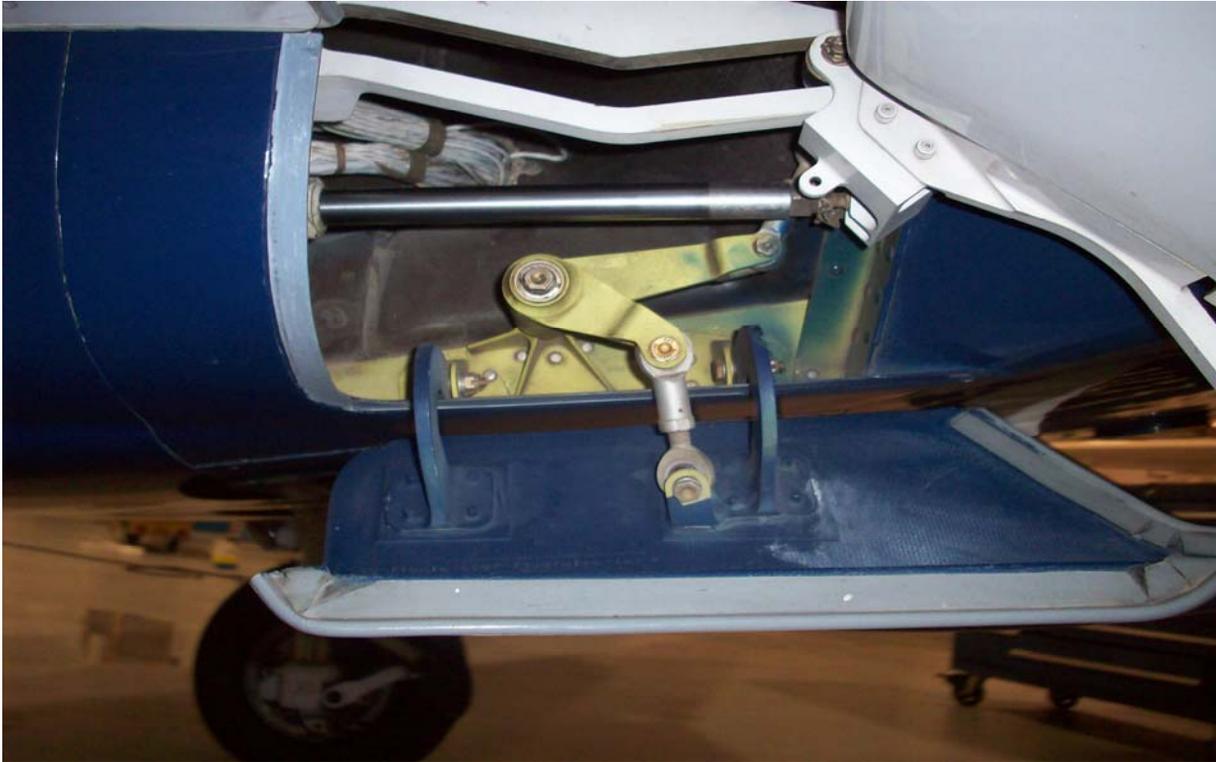
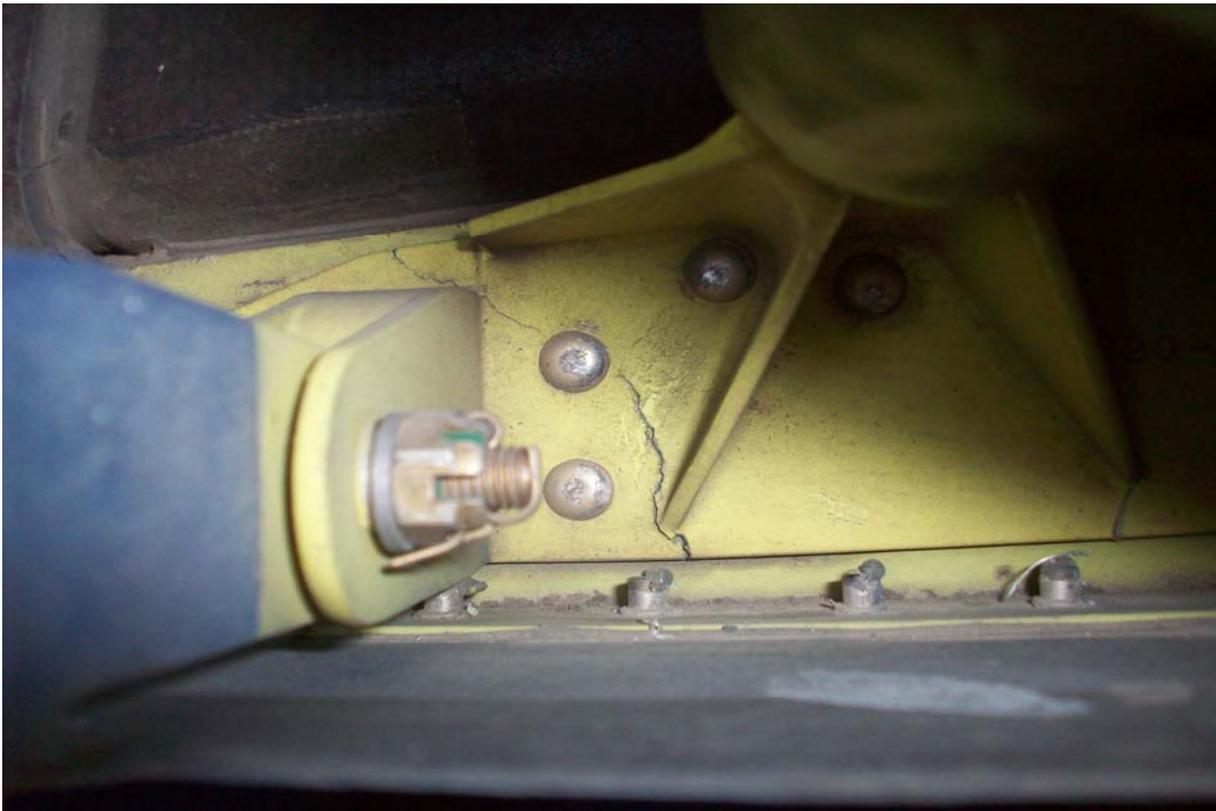
Model 390 Illustrated Parts Catalog
WING INSTL

A repair station technician writes, "During inspection of the wing flap actuator attachments, (I) found both the L/H and R/H wing inboard flap-fairing hinge fittings cracked (P/N's 390-110440-0001 and 390-110440-0002)."

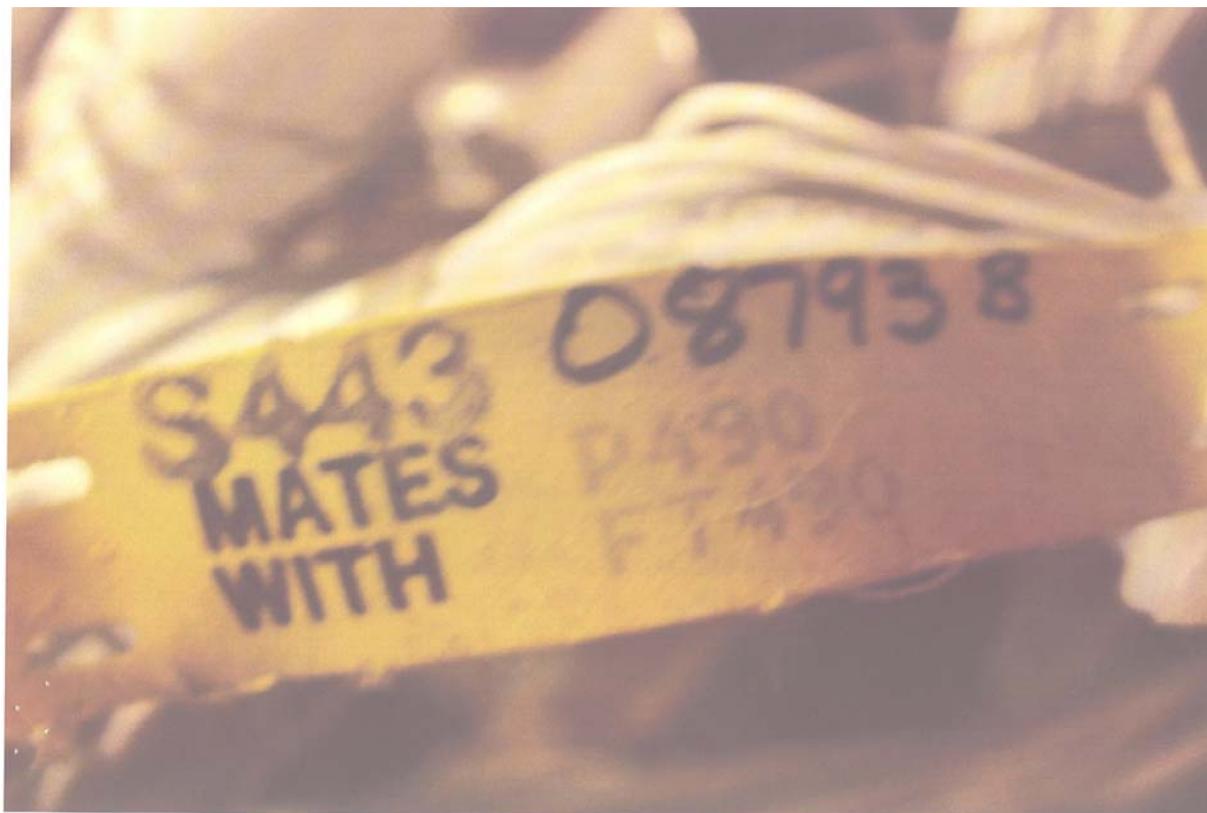
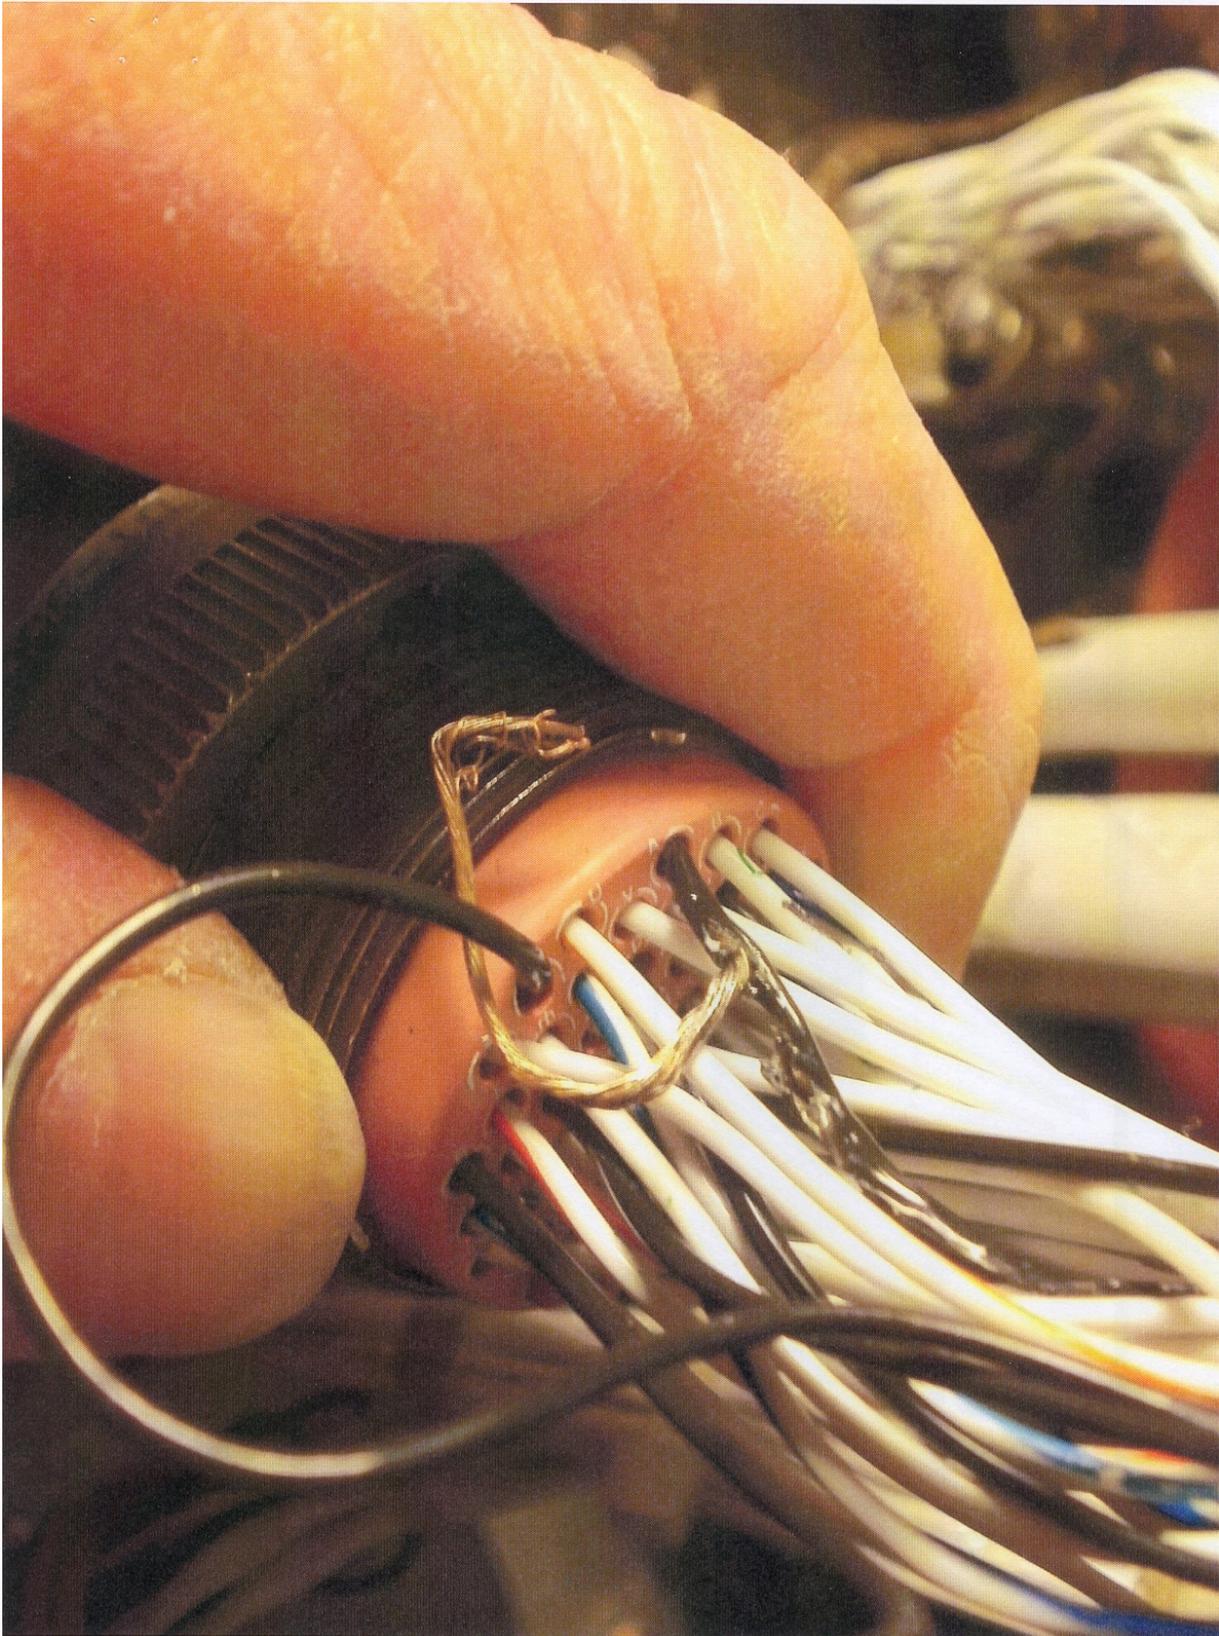
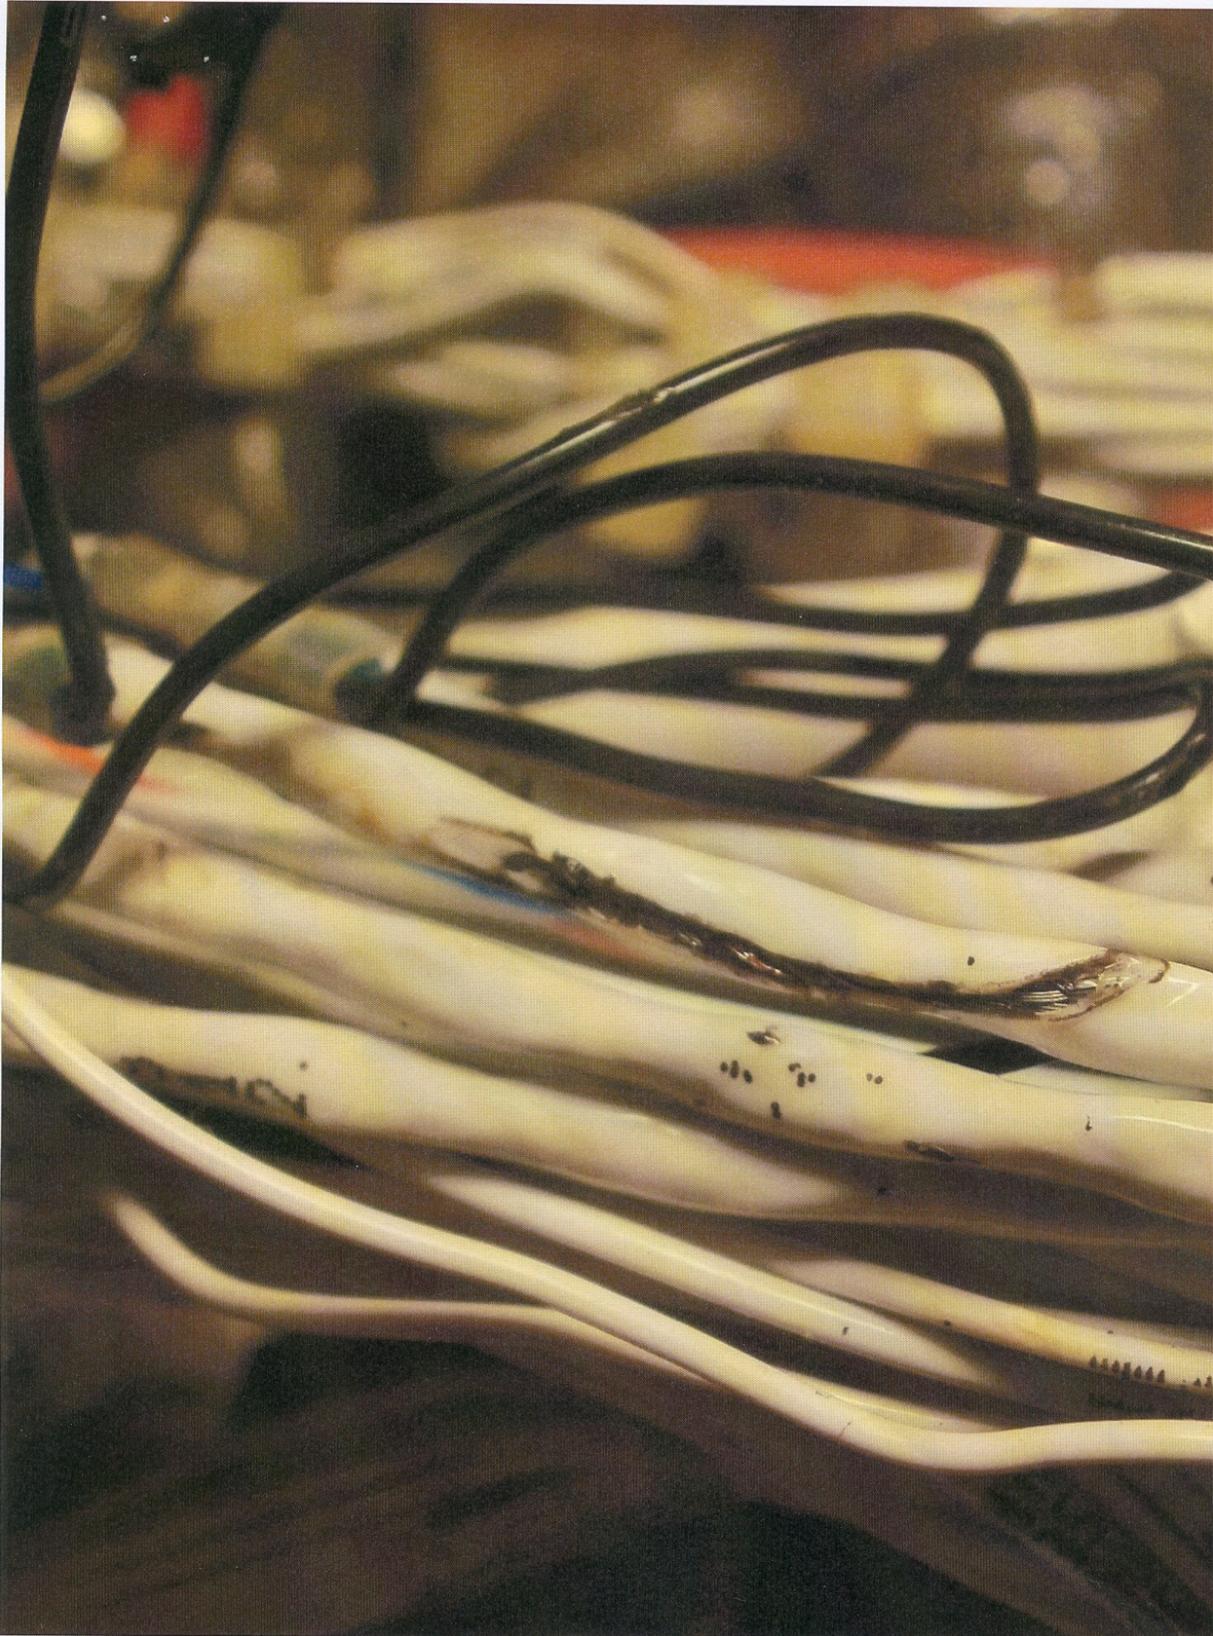
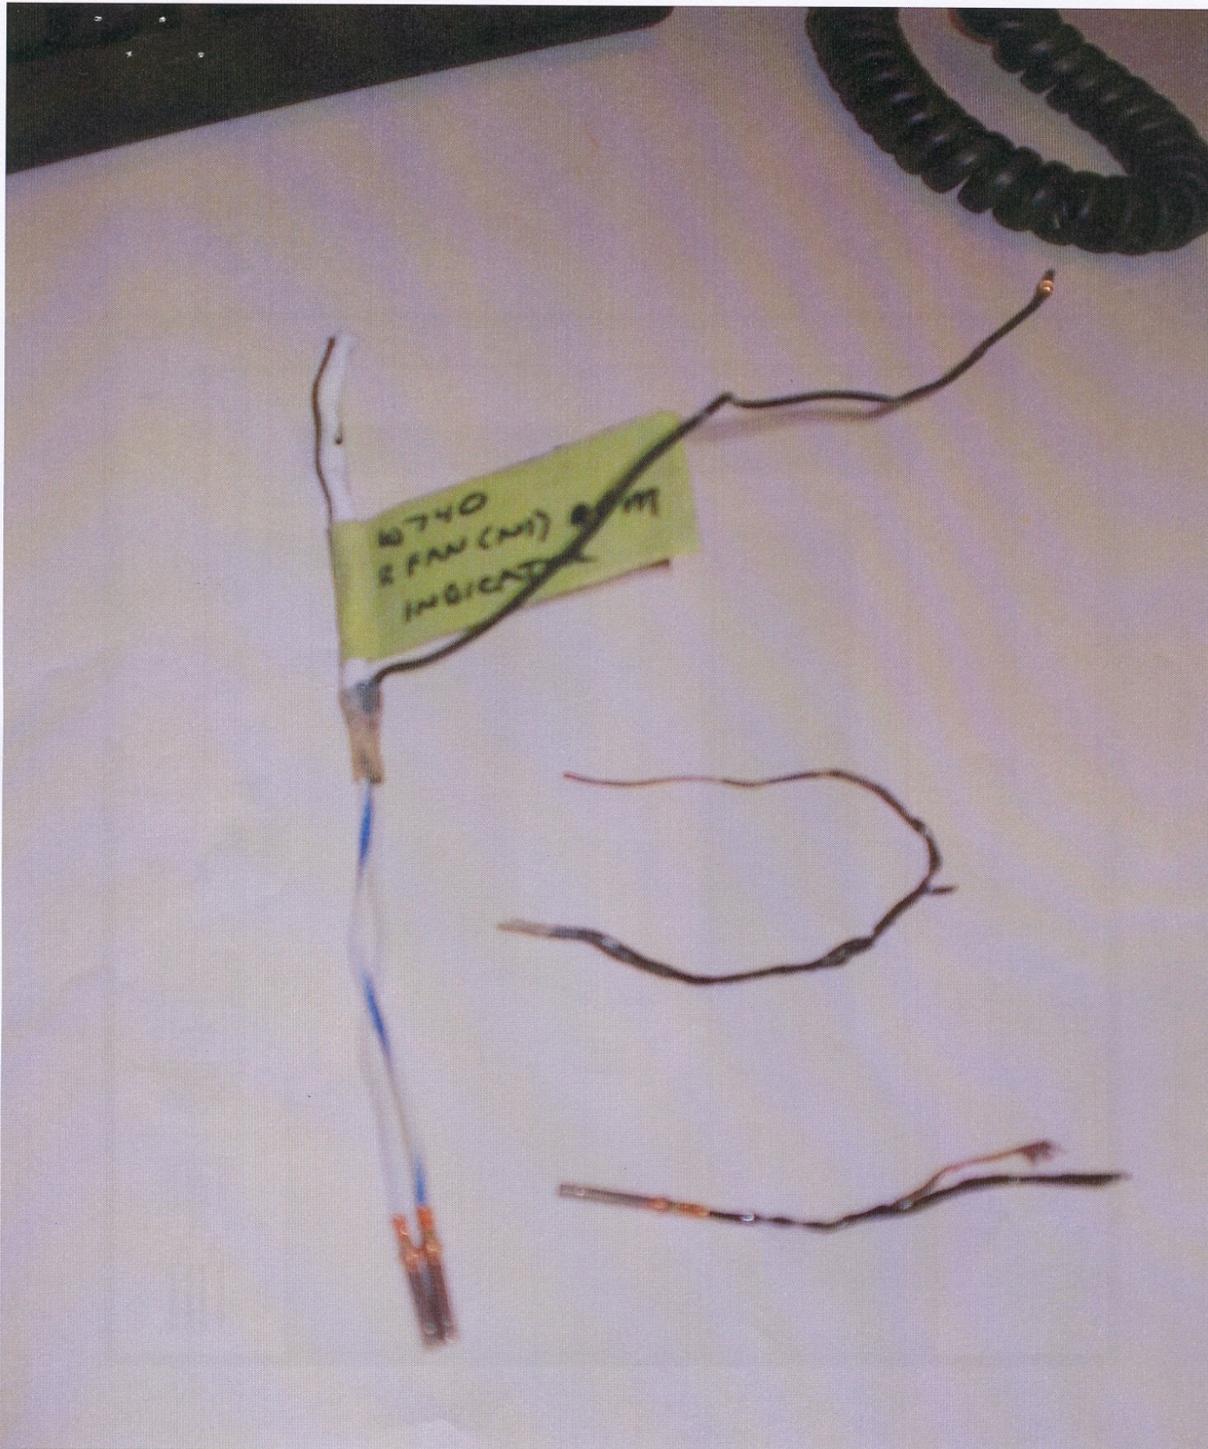
"A 'D' check inspection of the wiring in the aft baggage compartment (R/H, lower area) found some burned wires," says this repair station technician. "These wires had shorted out—burning through their insulation. (*Noted strands include*) W740 R/H Fan N1 RPM Indicator, and W748 R/H Turbine N2 Indicator.

"This (*area/wiring*) needs to be inspected thoroughly as (*failed wiring*) will cause indication problems in the cockpit and possibly a fire. The damaged wires were replaced."

(What caused the shorts? Chaffing? Poor connections? Impact damage? Now I have no idea "Who Done it"—Ed.)

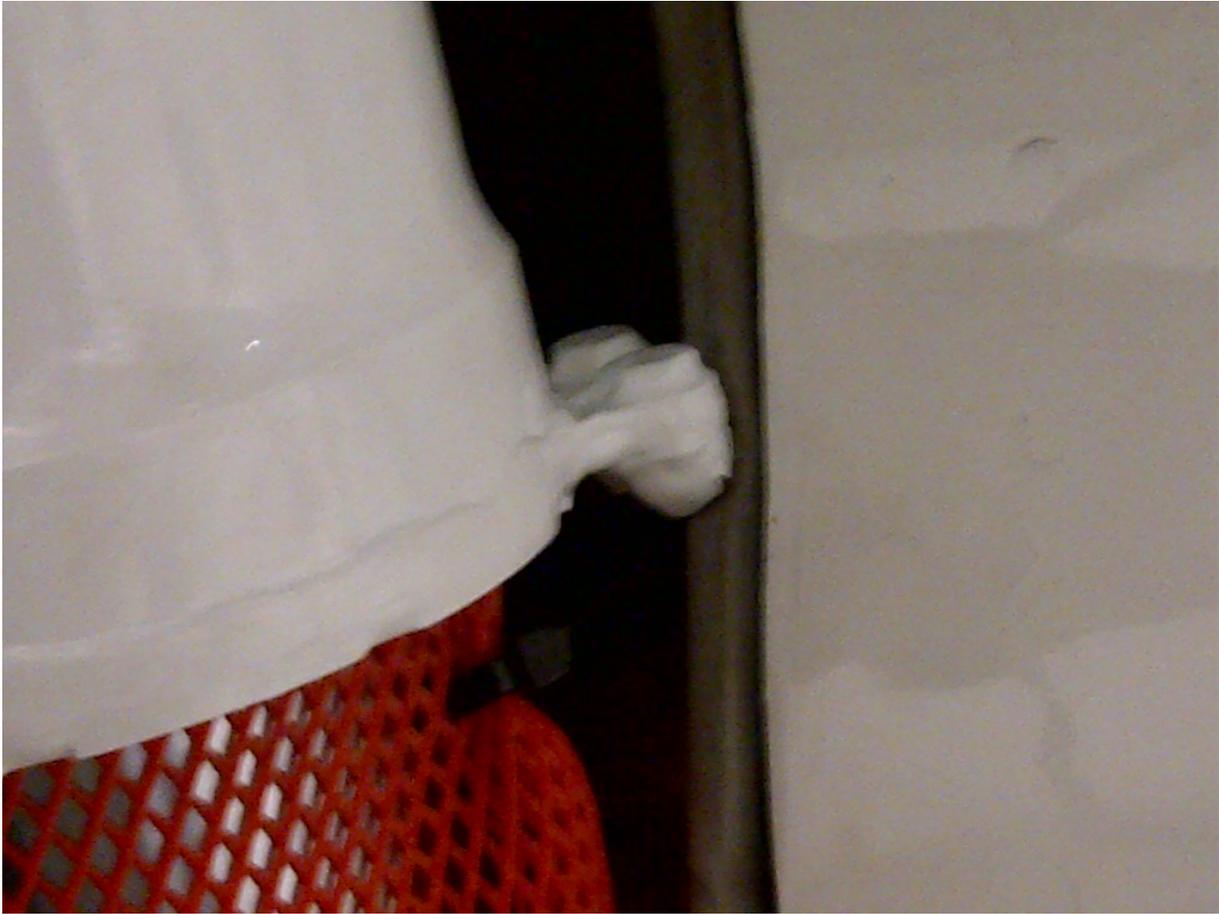
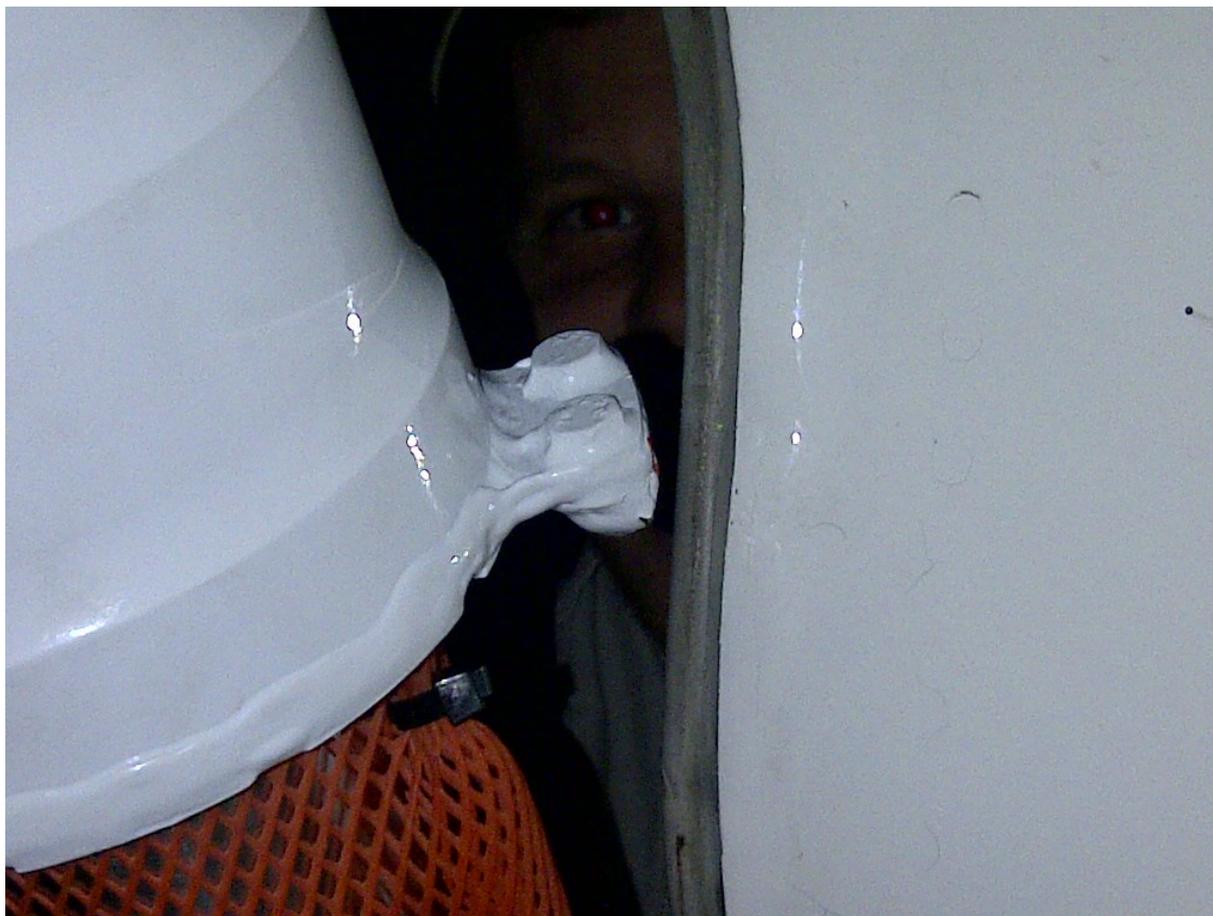
A technician for a repair station provides the following report of an assembly error and confusing assembly data. "During clearance checks (*I found*) the locking ring of the (*main landing gear*) shock strut assembly incorrectly clocked. (*This caused*) fouling of the aircraft structure and the failure potential for the L/H main gear extension.

"The CMM (*maintenance manual*) fails to note the 'dogged locking ring' requires installation in a specific direction to maintain airframe clearance. (*Reference the following*) steps in CMM 6100, section 32-10-05: '(14) Apply sealing and coating compound listed in paragraph 3 to both faces of dogged locking ring (6239-1); (15) Install the dogged locking ring on the gland nut (6228-1). Install the gland nut on the flange of the cylinder S/A (6217-1) using gland nut wrench CAT (4948-6C). Ensure the dogged locking ring is correctly centered on the gland nut. Torque gland nut to 22.60-45.20 NM. Note: back off to nearest lock position only when necessary. (16) Engage the tab of the locking segment (6233-1) with a slot in the gland nut. Secure the locking segment to the dogged locking ring with 2 bolts (AN4-5), 2 washers (AN960-416L), and two nuts (MS17826-4). Torque nuts to 5.65-7.91 NM. Safety the nuts with cotter pins (MS24665-151).'

"The data fails to state the dogged locking ring may be installed in either the 0500 or 1100 (*o'clock*) positions—relative on the assembly. However, only the 0500 position provides adequate airframe clearance once the landing gear is placed in the aircraft. Installation of the lock ring 180 degrees (out) or at the 1100 position allows the tab of the lock ring to interfere with the aircraft structure at the aft side of the gear well."

(Shock P/N: 60185001; Assembly P/N: 601850281. I was so intent on observing the locking ring clearances between the two photos I did not initially catch the background "face". Trick shot! Ed.)

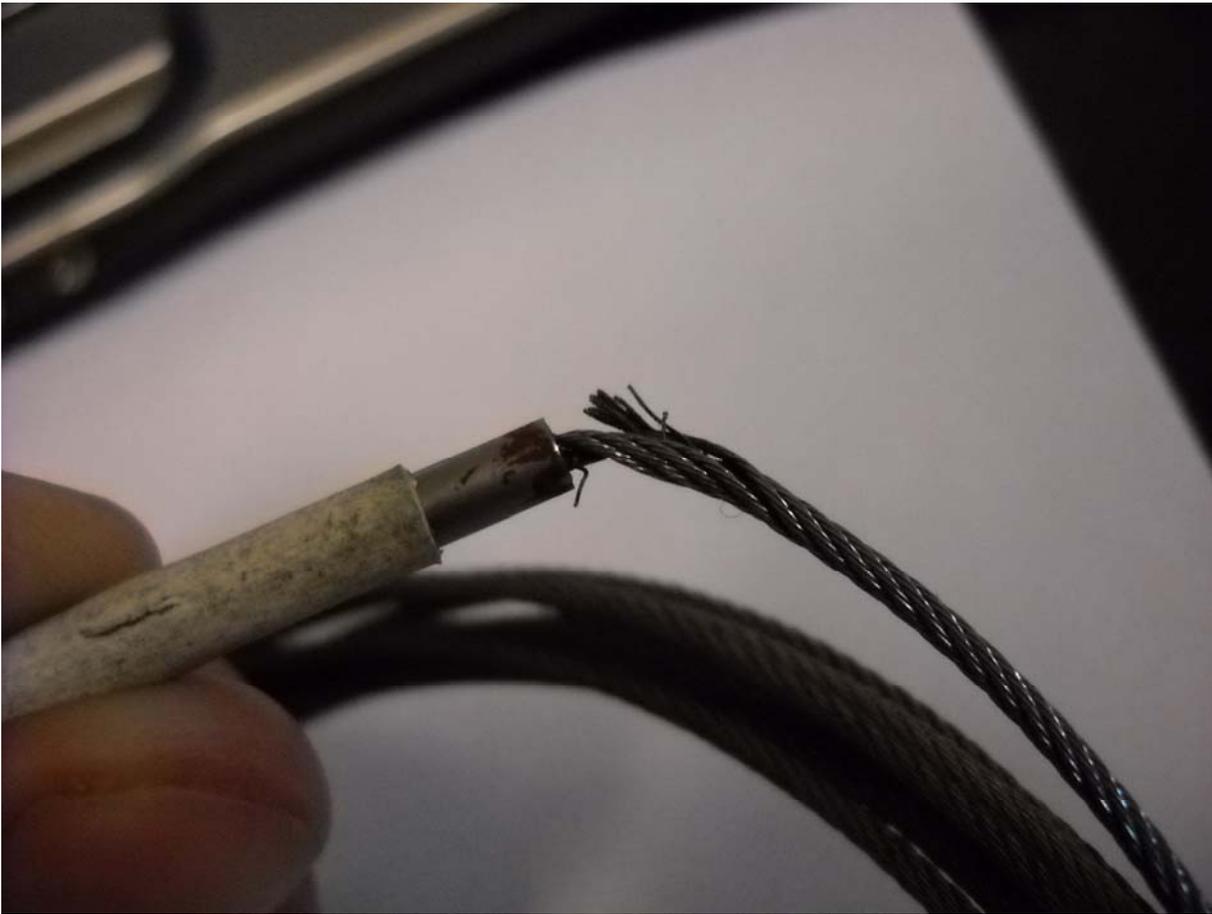
A mechanic states, "During a routing inspection, (I) found a flap cable (P/N 2660001105) frayed at the connection to the fairlead—about 30 percent of the (*strands*) were broken. (*It*) runs from the inner bell crank to the outer end of the flap. This cable was original as far as can be traced back—the original P/N tag was still installed. (*And*) judging from the slip mark, the cable had not (*moved from its swaged fitting*)."

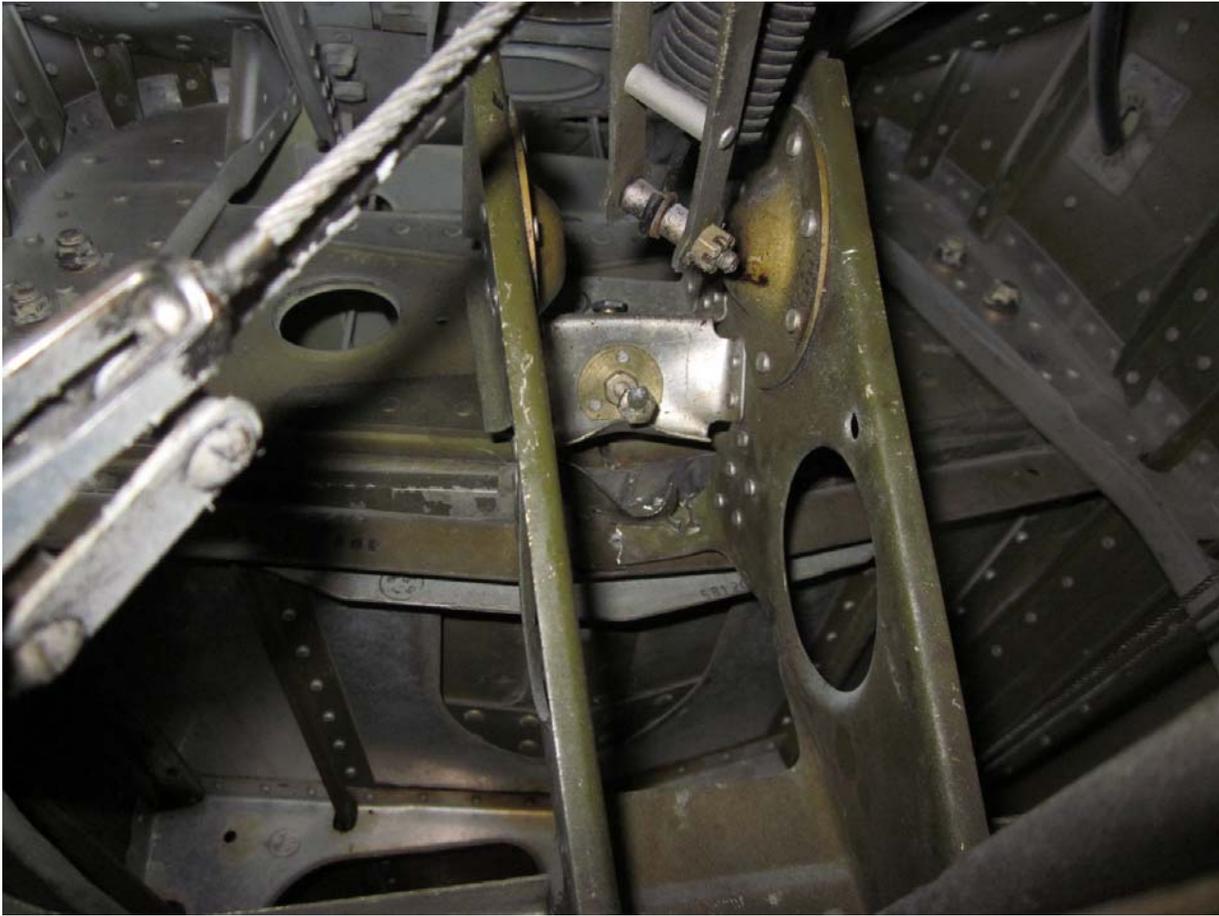
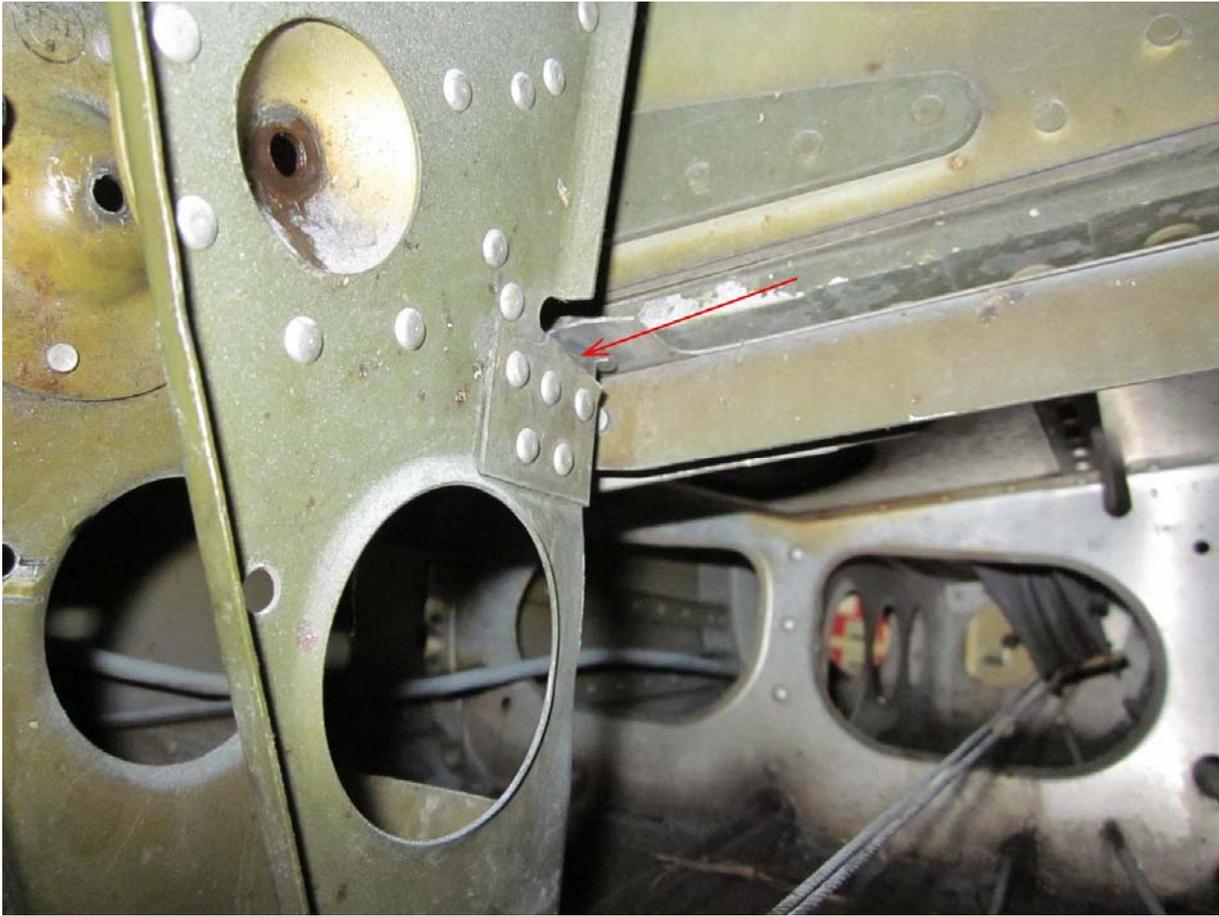
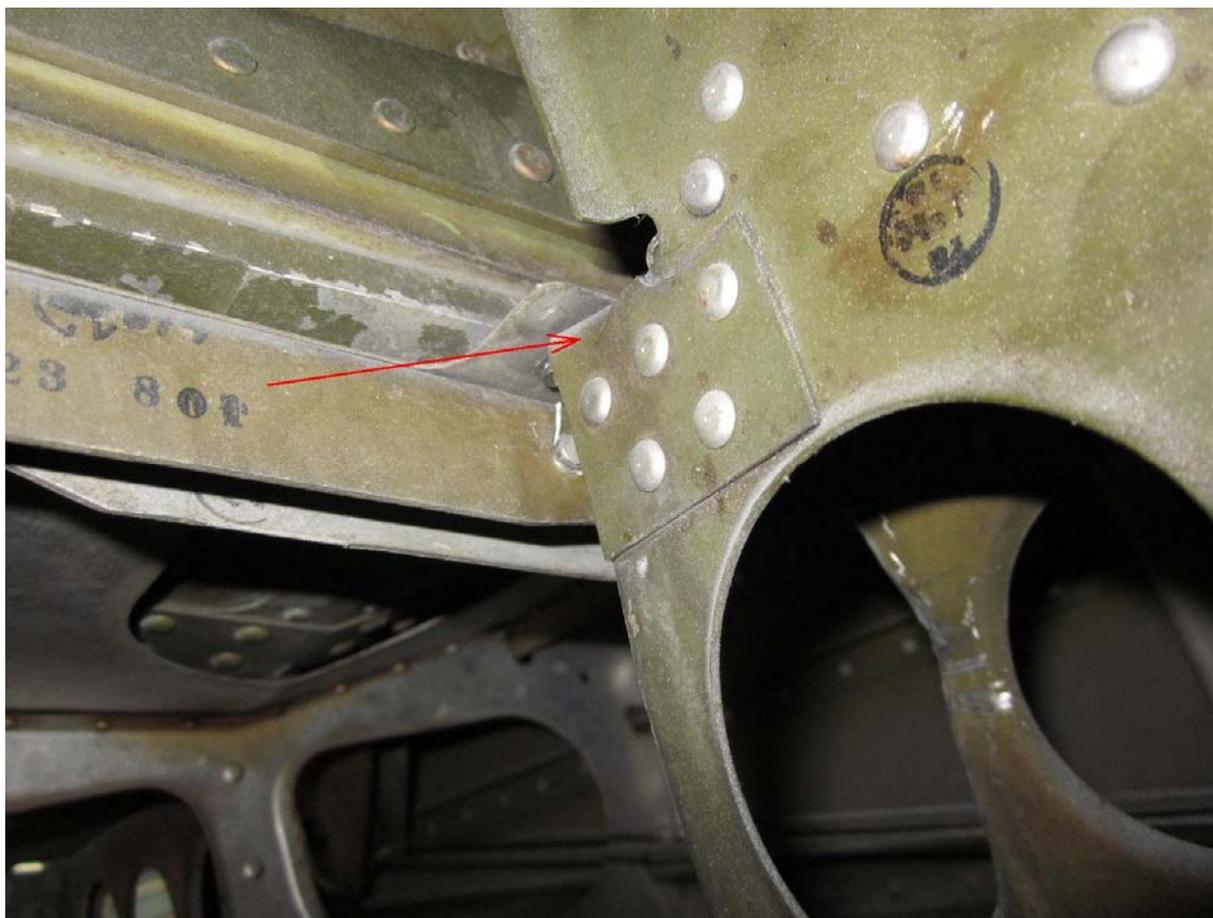
"While this aircraft was tied down," says a submitter, "the control wheel was secured in the full up position with a seat belt—instead of the approved gust lock device. This (*ad hoc arrangement*) allowed the elevators to have some movement—high winds prior to the intended flight (*allowed the elevator*) to hammer its lower stop until the bracket's upper mounts failed.

"The pilot stated he conducted a flight control check prior to taxi—everything felt fine. It was not until the control surface (*incurred*) an air load that he discovered a problem and aborted the takeoff."

(No P/N's were provided with this report. Red arrows are my insertions—Ed.)

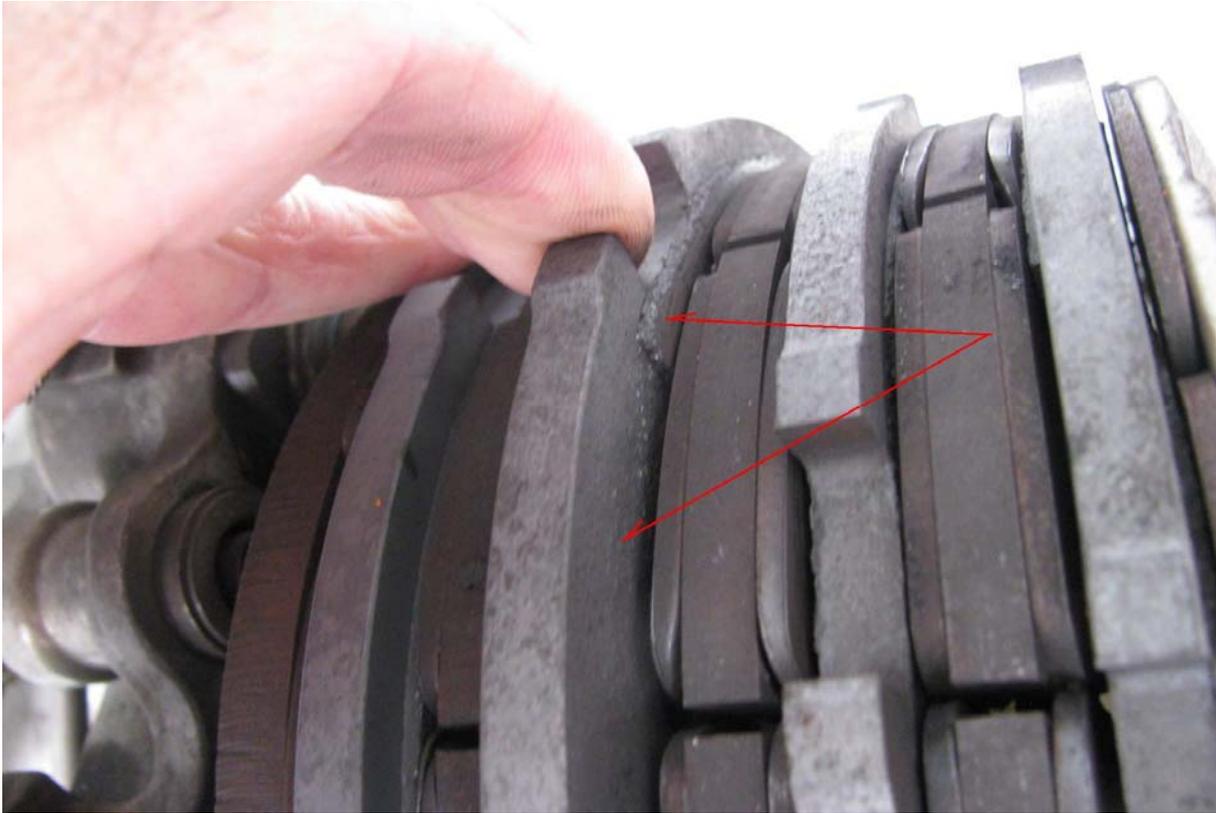
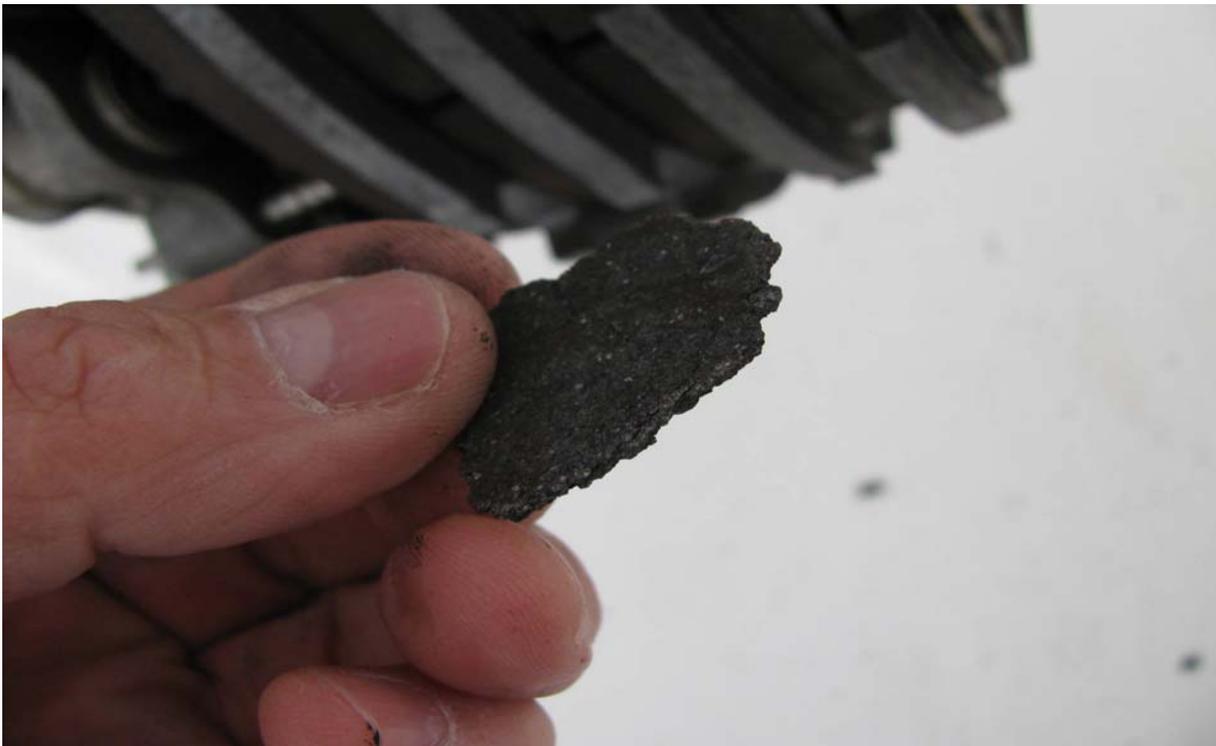
A submission from a corporate operator states, "The brake pads on both the L/H and R/H brake rotors are debonding—with 'chunks' missing." (*Rotor P/N: 90006028; Brake Assembly P/N: 90006022. Red arrows are my insertions—Ed.*)
