**Federal Aviation
Administration**

ADVISORY CIRCULAR

AVIATION MAINTENANCE ALERTS

**ALERT
NUMBER
407**

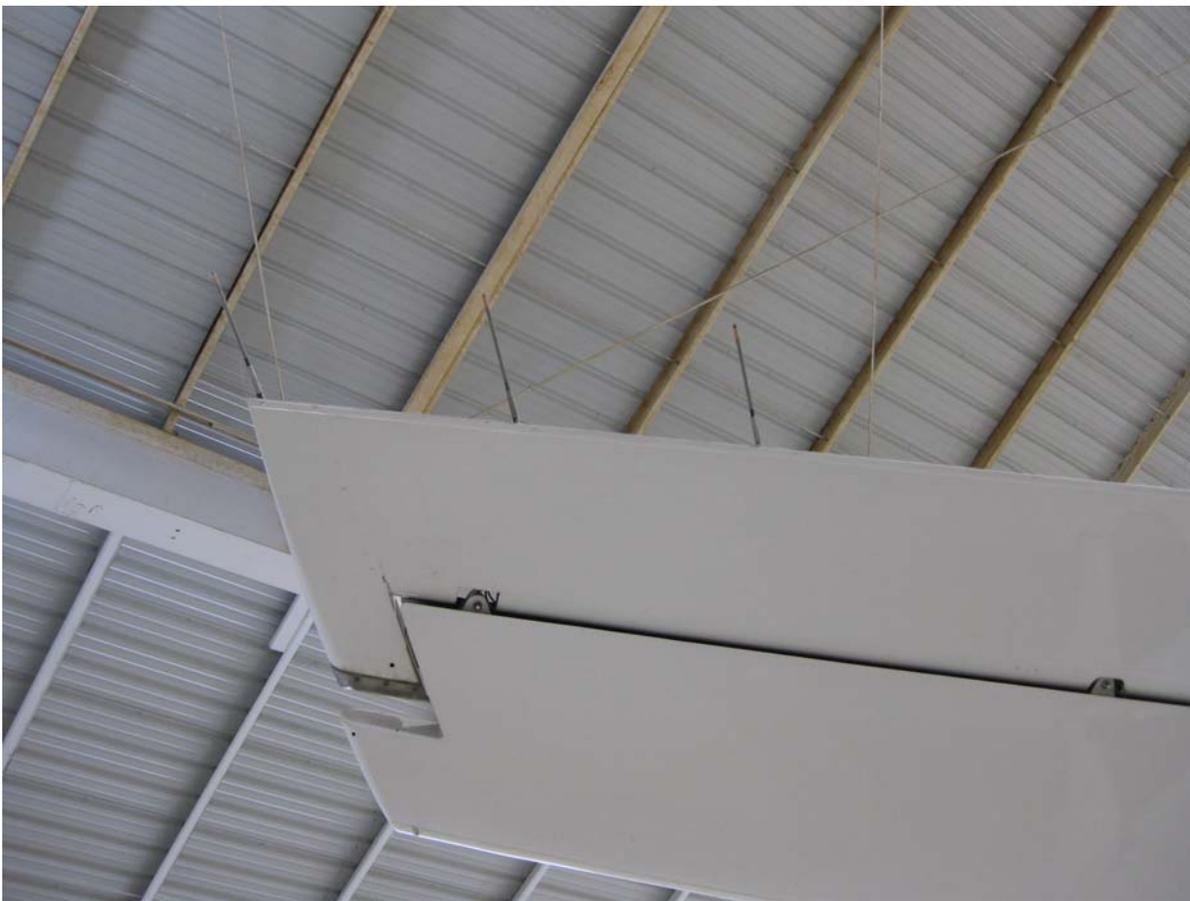
"A very simple way to ensure the correct elevator is installed on the proper side is to verify the location of the static wicks—they must be on the upper surface of the elevator. This fact is reflected in the additional note added to the P180 *Avanti* AMM."

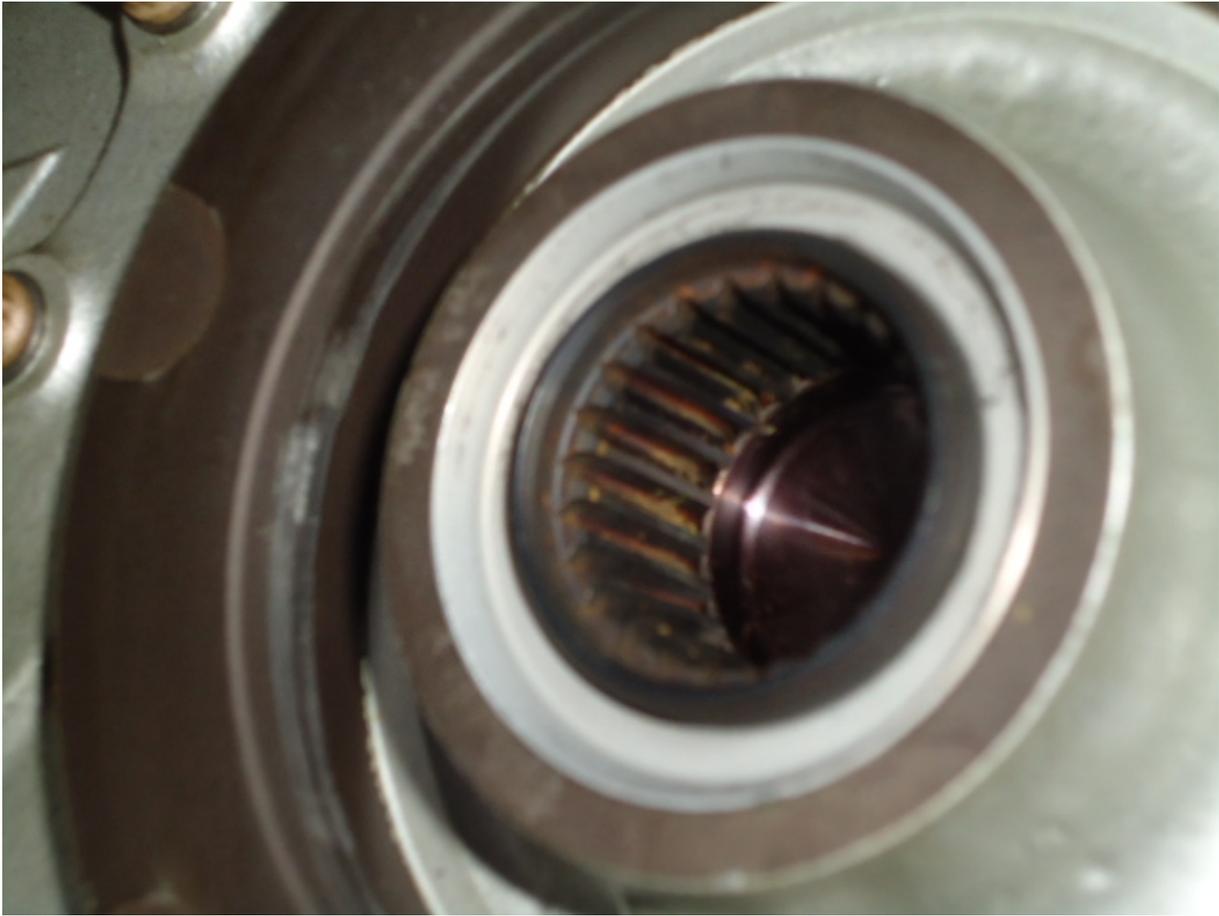
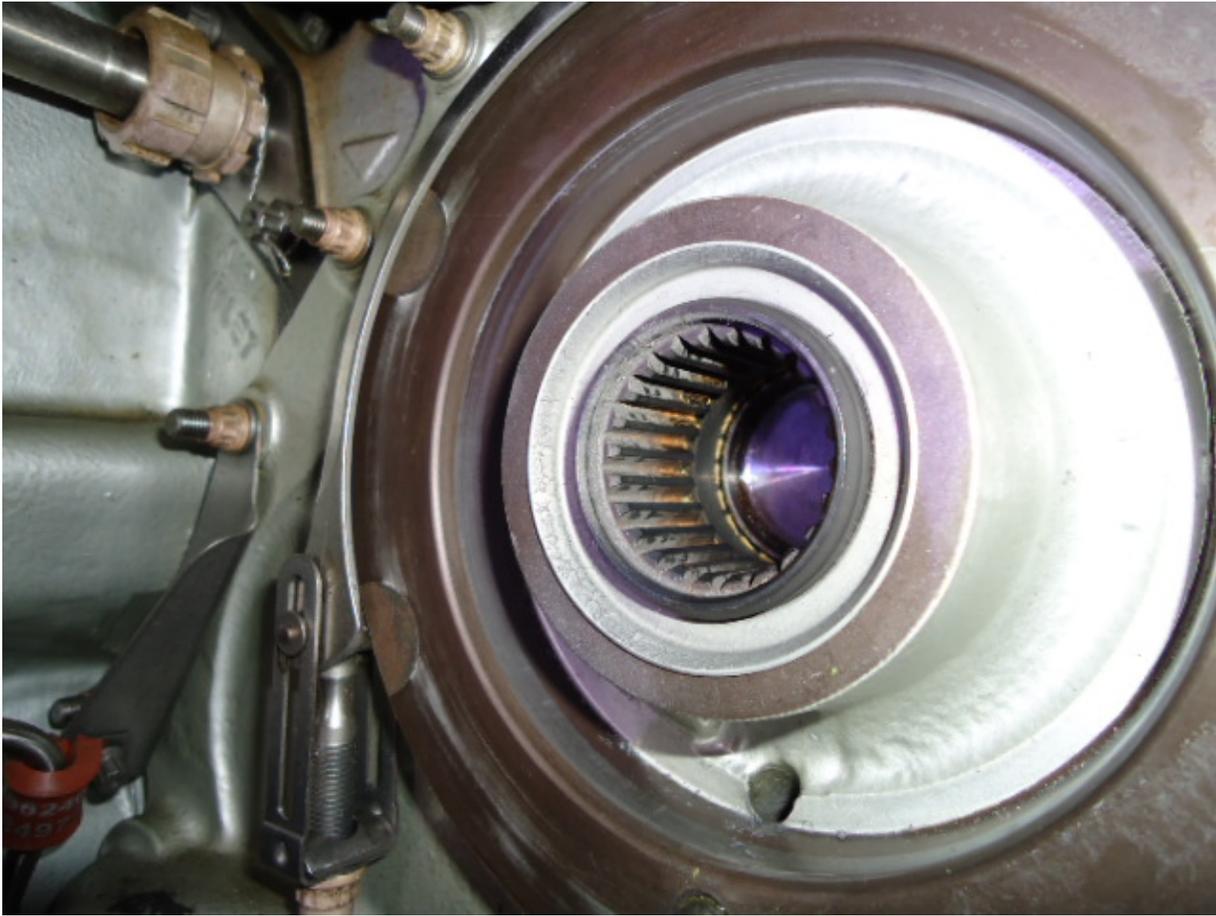
"While performing a SB (Service Bulletin) to replace the fuel pump spline adapter, we found the engine driven fuel pump drive shaft to be migrating out of the fuel pump and into the accessory gear case. Upon inspection of the gear case, we found a retaining plug in the gear case spline to be pushing into the gear case—allowing the fuel pump drive shaft to migrate out of the fuel pump." *(Gear box P/N: 39500221.)*
