**Federal Aviation
Administration**

ADVISORY CIRCULAR

AVIATION MAINTENANCE ALERTS

**ALERT
NUMBER
412**

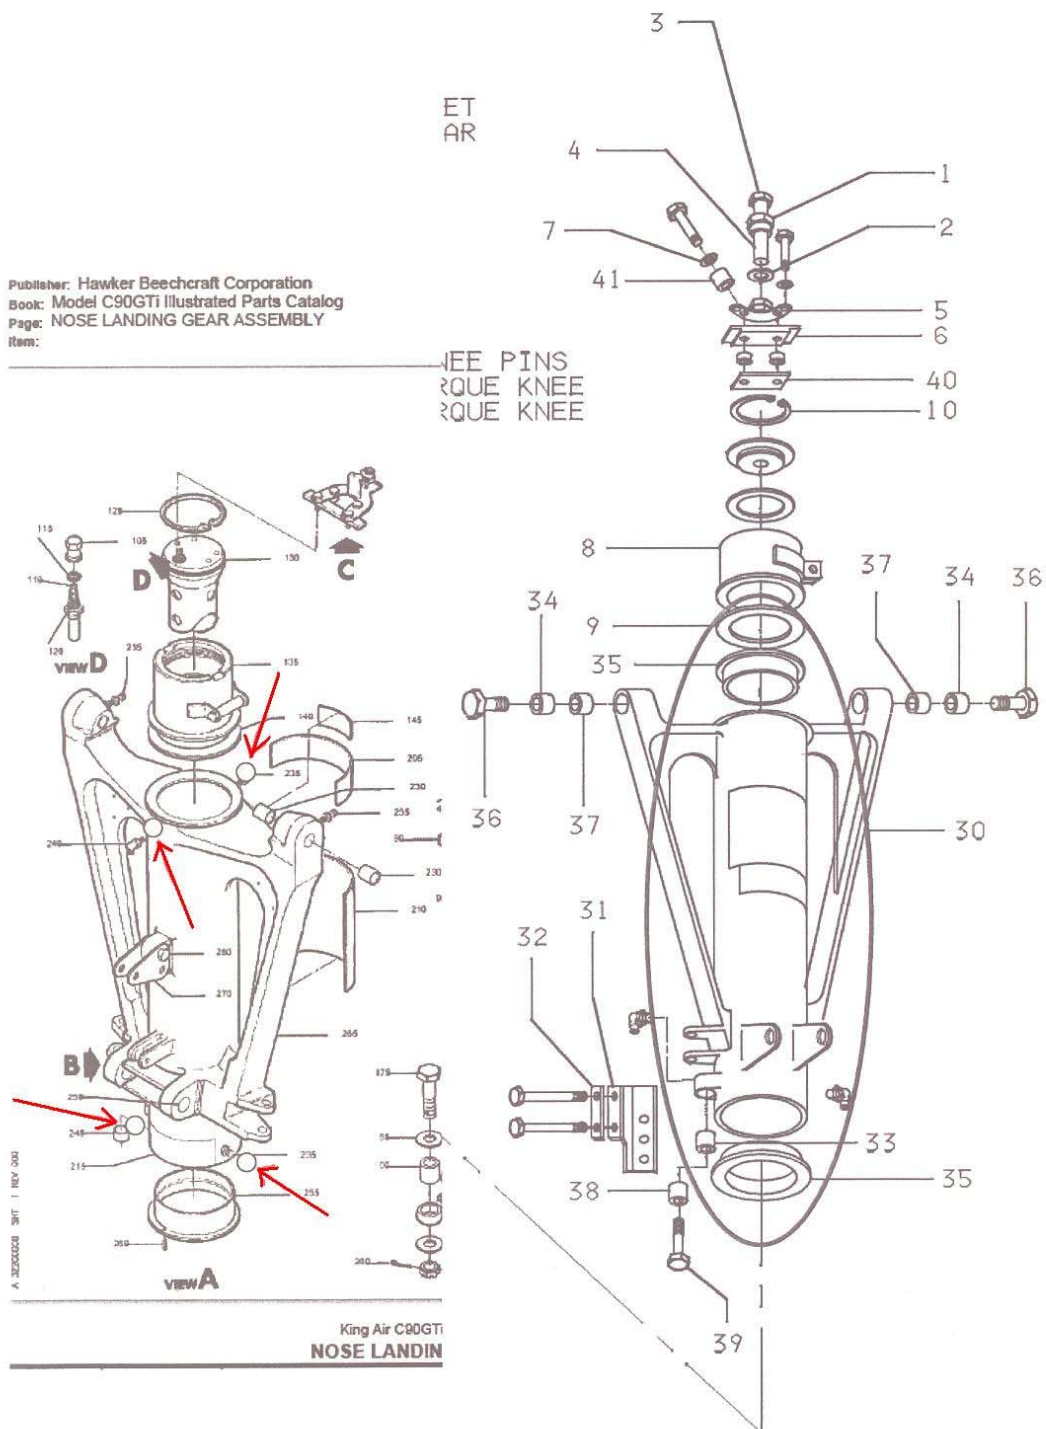
Beechcraft: C90GTX; Failed Nose Wheel Steering; ATA 3250

A repair station technician states, "Coming from the taxi holding bay, the aircraft went out of the runway—the nose wheel steering was (*apparently*) inoperative. Investigation and inspection performed by maintenance found a lack of grease on the steering brace (P/N 101-820024-15). No other findings or problems were detected on the steering (*assembly*). After grease (*application*), operational and functional tests performed smoothly.

Recommendation: the steering brace must be greased with the aircraft both on and off jacks to guarantee full (*lubrication*)."

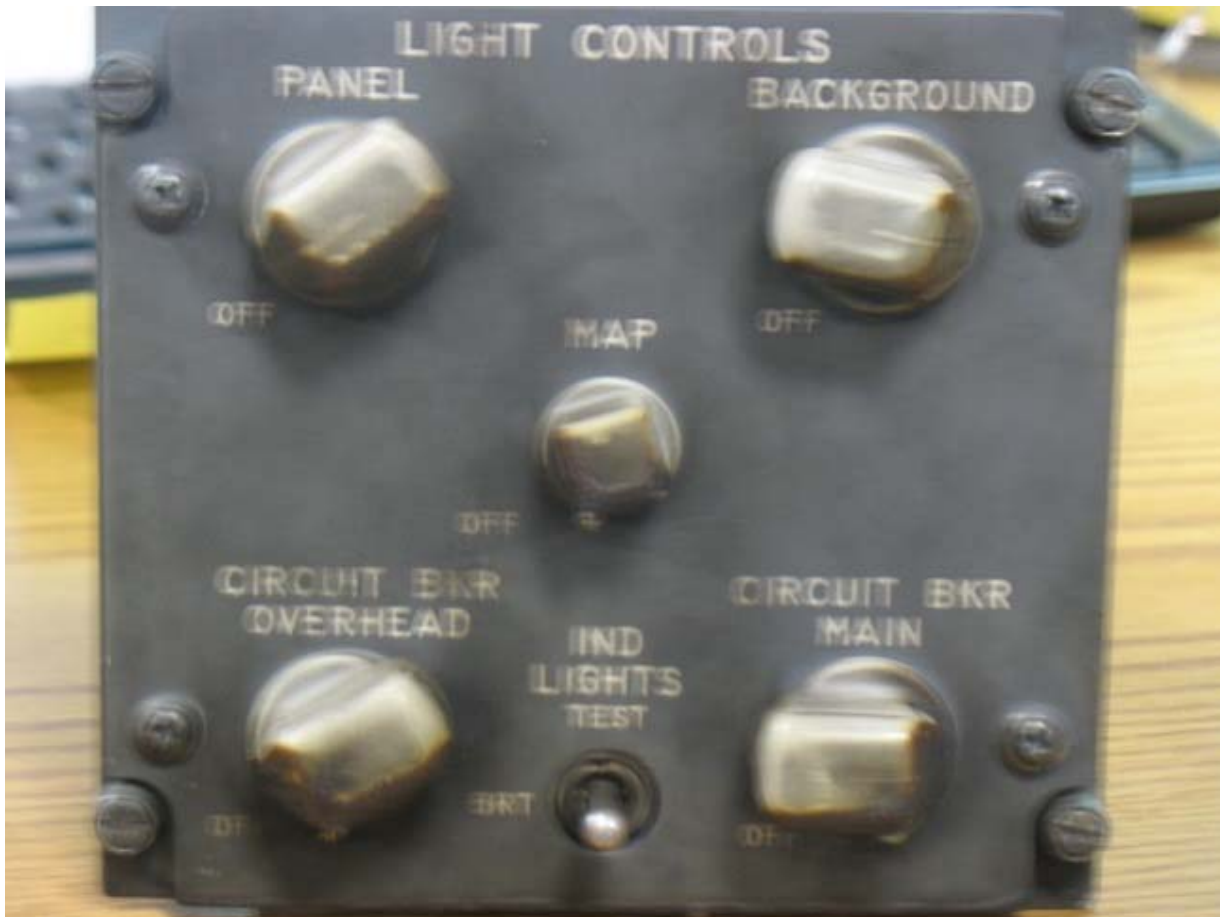
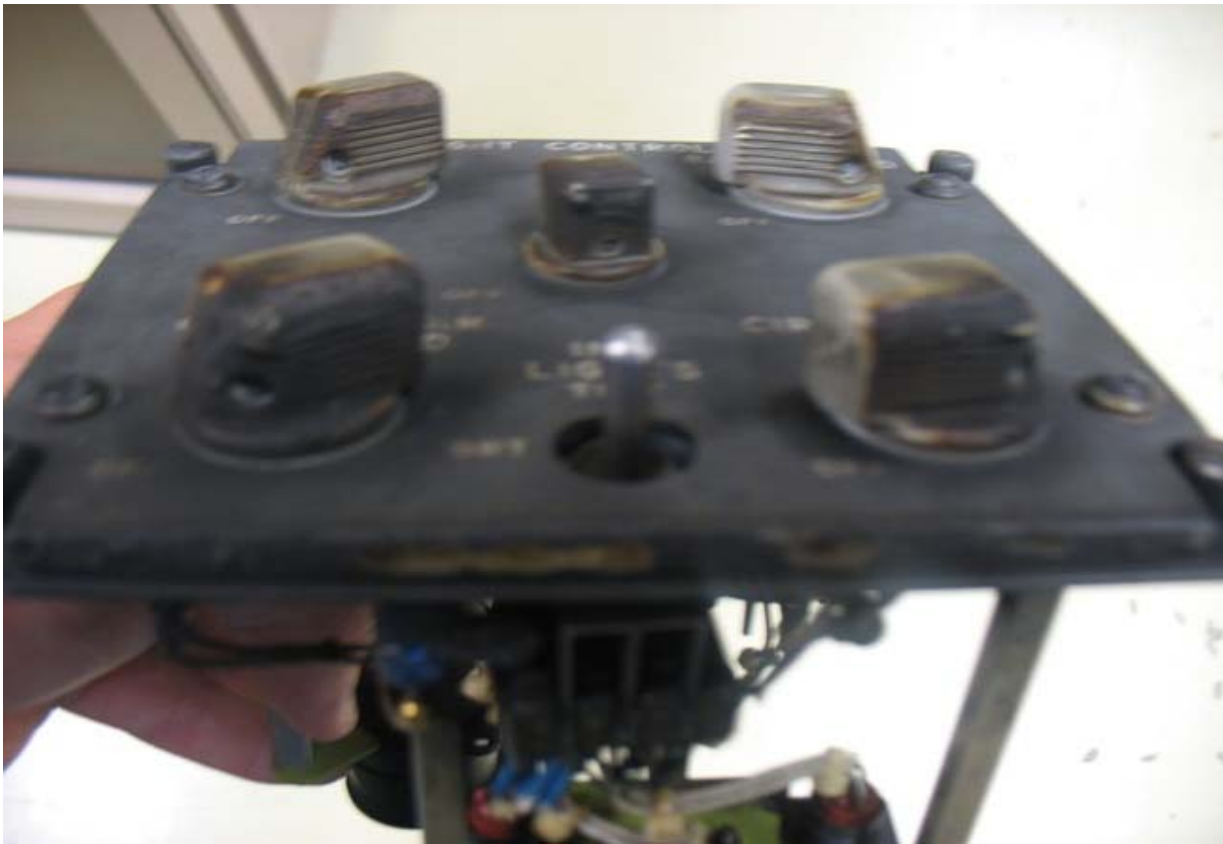
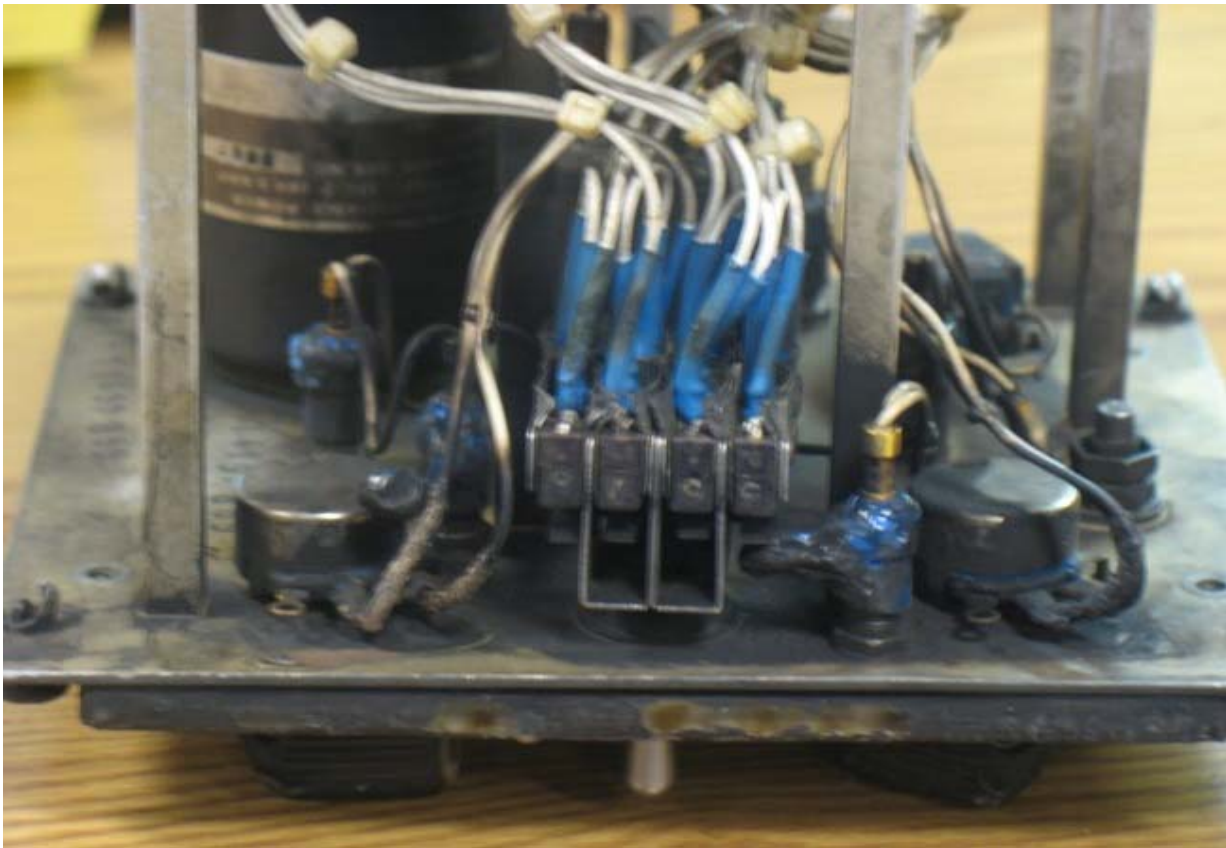
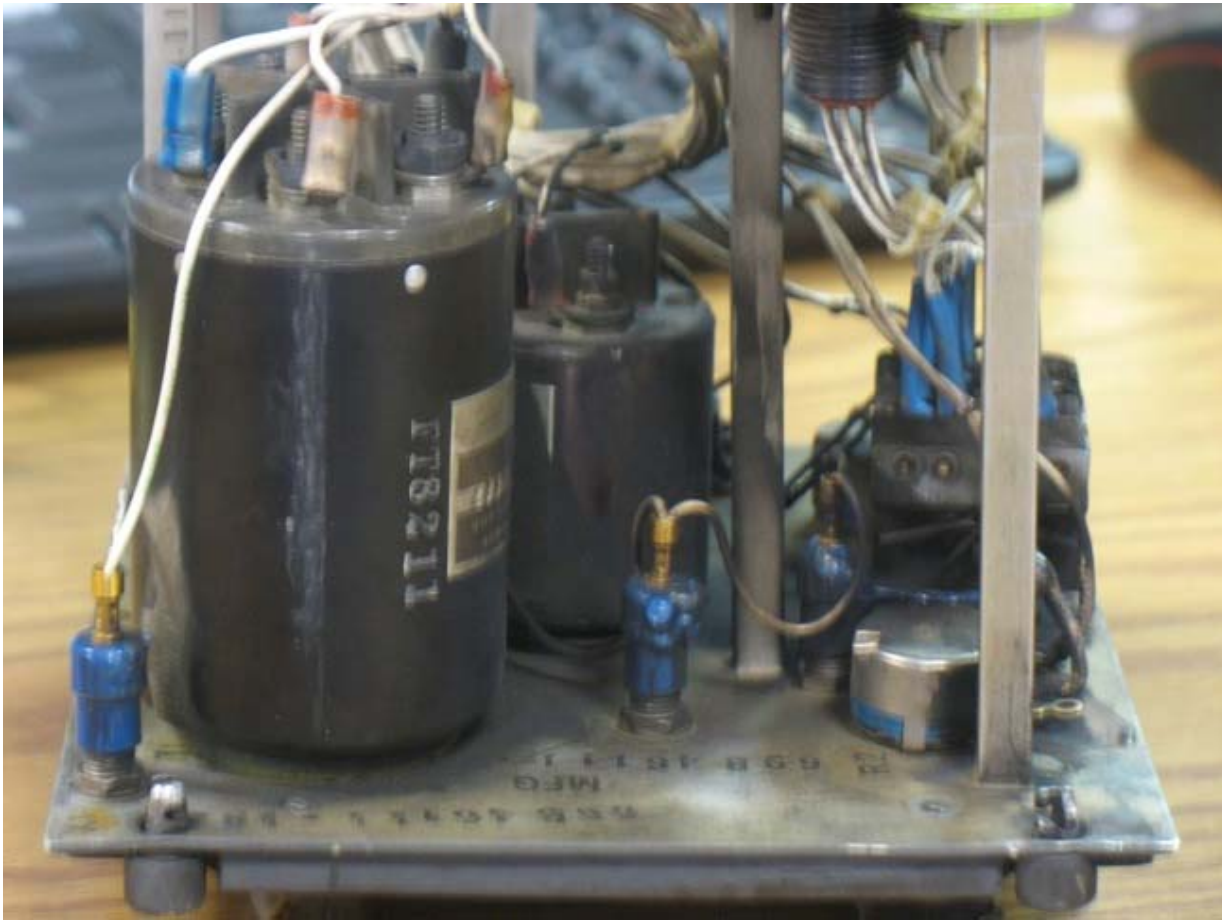
Boeing: 747; Burned Light Controls; ATA 3300

"A (*foreign*) airline sent P/N 69B46111-10 (*control panel*) to our repair station, " says this submitter. This panel is badly burned. Either it was the cause of a fire, or it was burned when an adjacent panel caught fire. We have contacted the airline to find out if an incident was reported, and to (*determine*) if other panels have been sent to our repair station that may have been (*similarly*) exposed. They have not responded (*at this time*)."

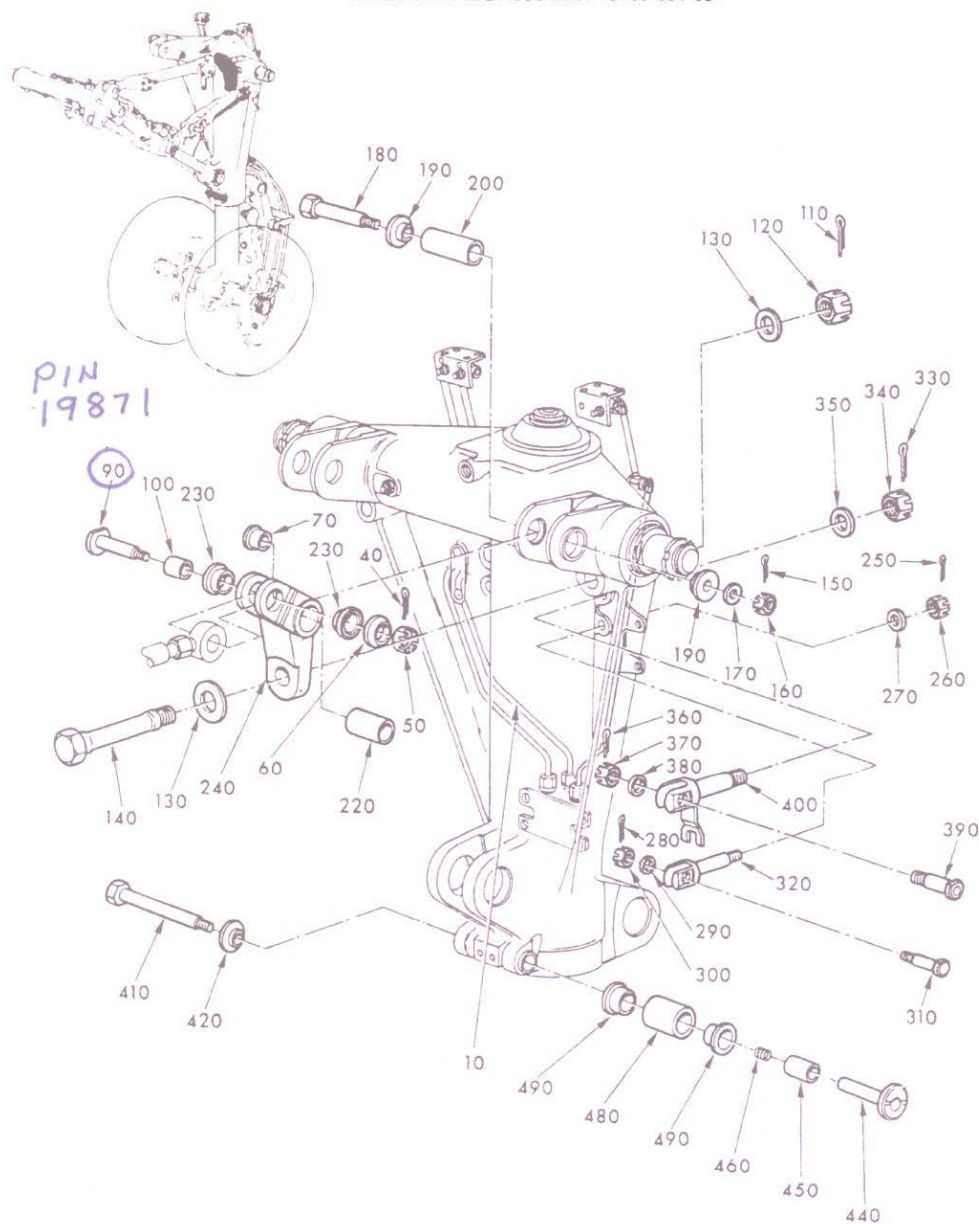
LH-RH MAIN LEG ASSEMBLY
 JAMBE PRINCIPALE EQUIPEE GAUCHE, DROITE
 FIGURE 2

Embraer: 120ER; Worn MLG Actuator Rod-end; ATA 3230

"Maintenance found the left gear was not retracting fully up and locking into position. The problem was (*determined*) to be excess play in the retract actuator rod-end (P/N 21126-000-00). This rod-end bearing (swivel) was found seized to the attaching pin that secures the actuator to the MLG leg. This caused the rod-end to pivot on the OD (*outside diameter*) of the pin—instead of the bearing rotating on the rod-end bearing race. The pin (P/N 19872) was found worn 0.064 inches deep approximately 210 degrees around the OD circumference. The actuator, pin, and bushings were replaced. The landing gear system checked 'good' and the aircraft was returned to service." (*This particular rod-end P/N is found four times in the SDRS database.*)

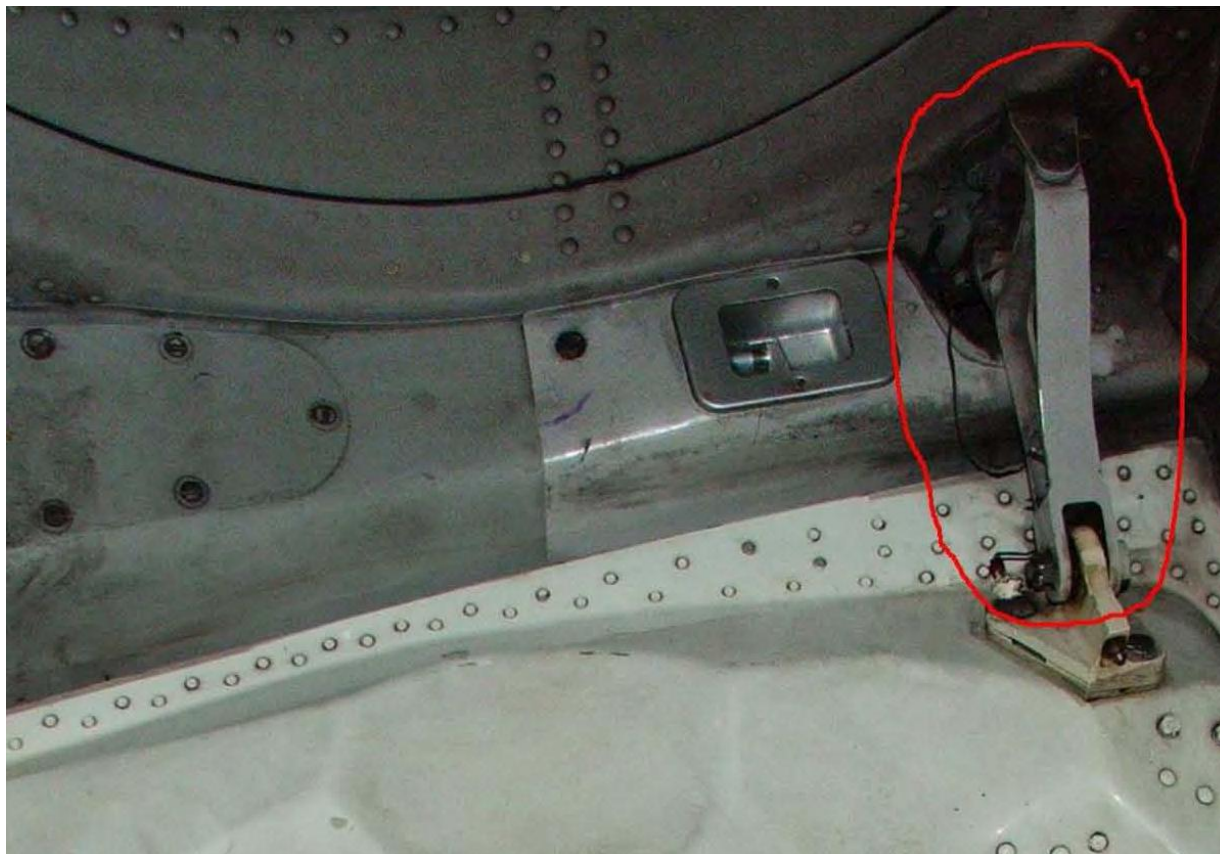
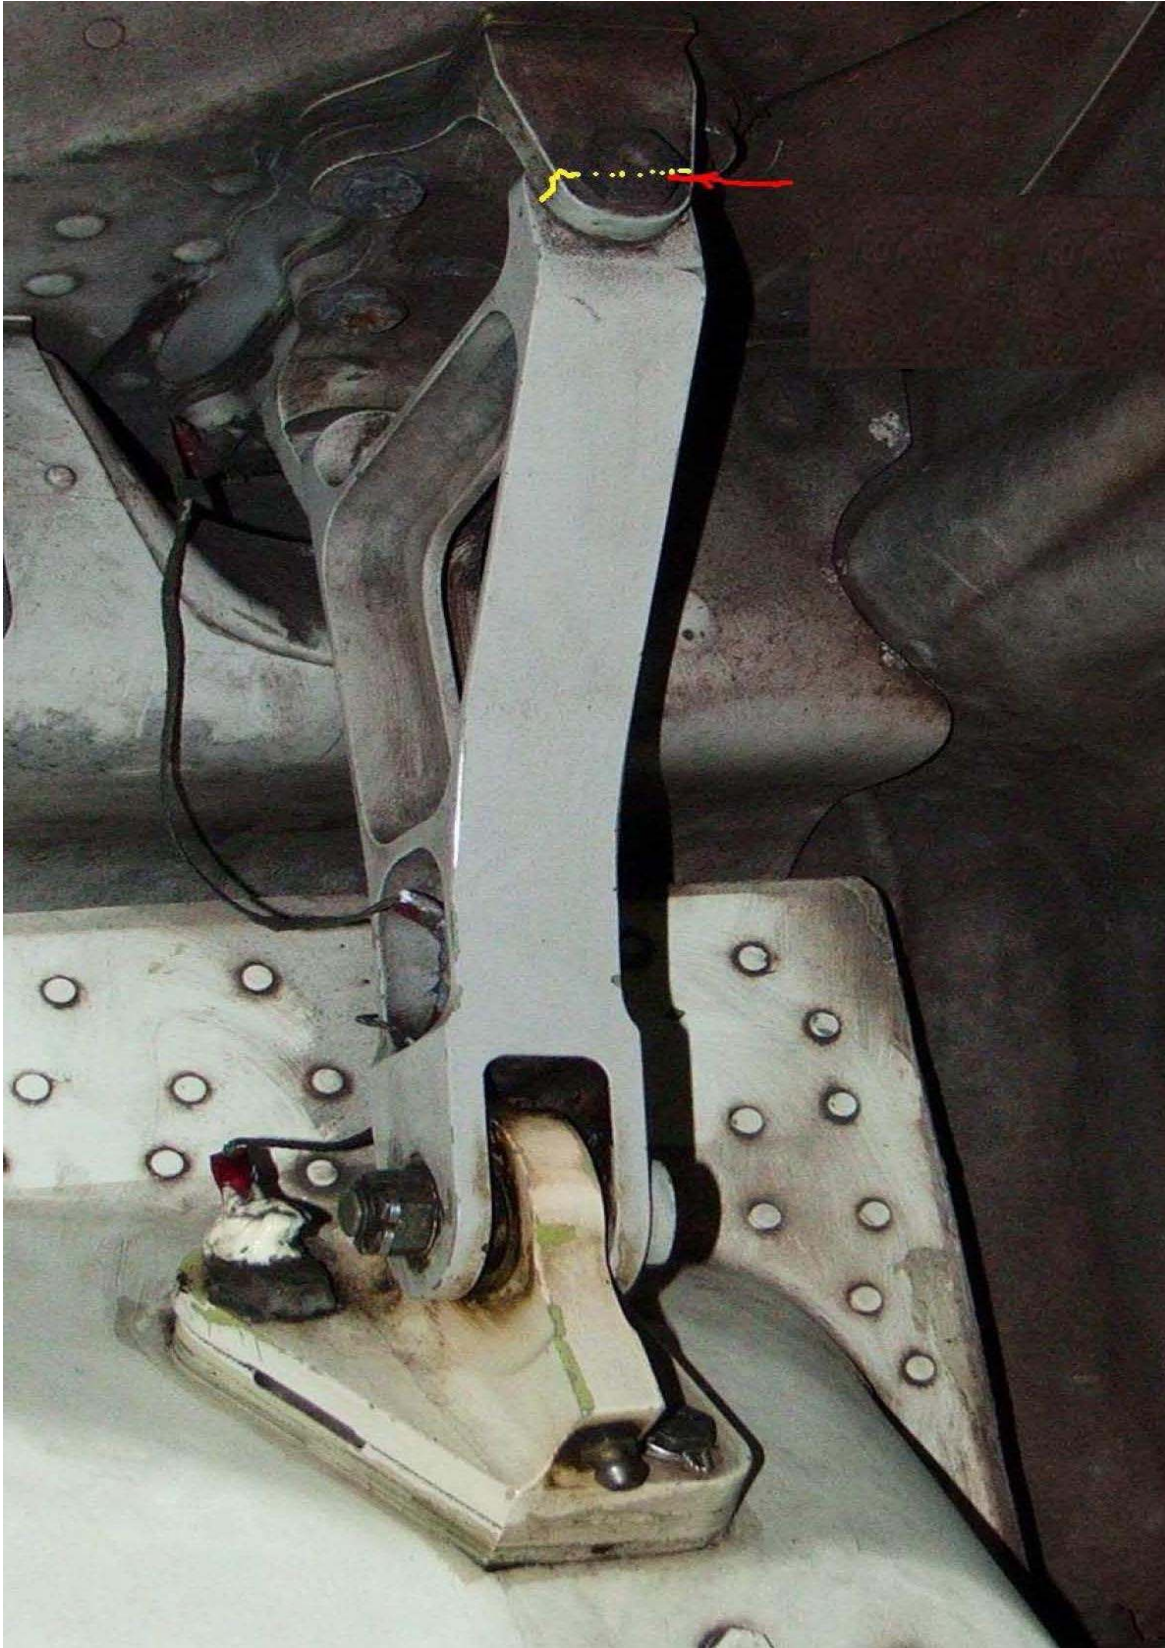
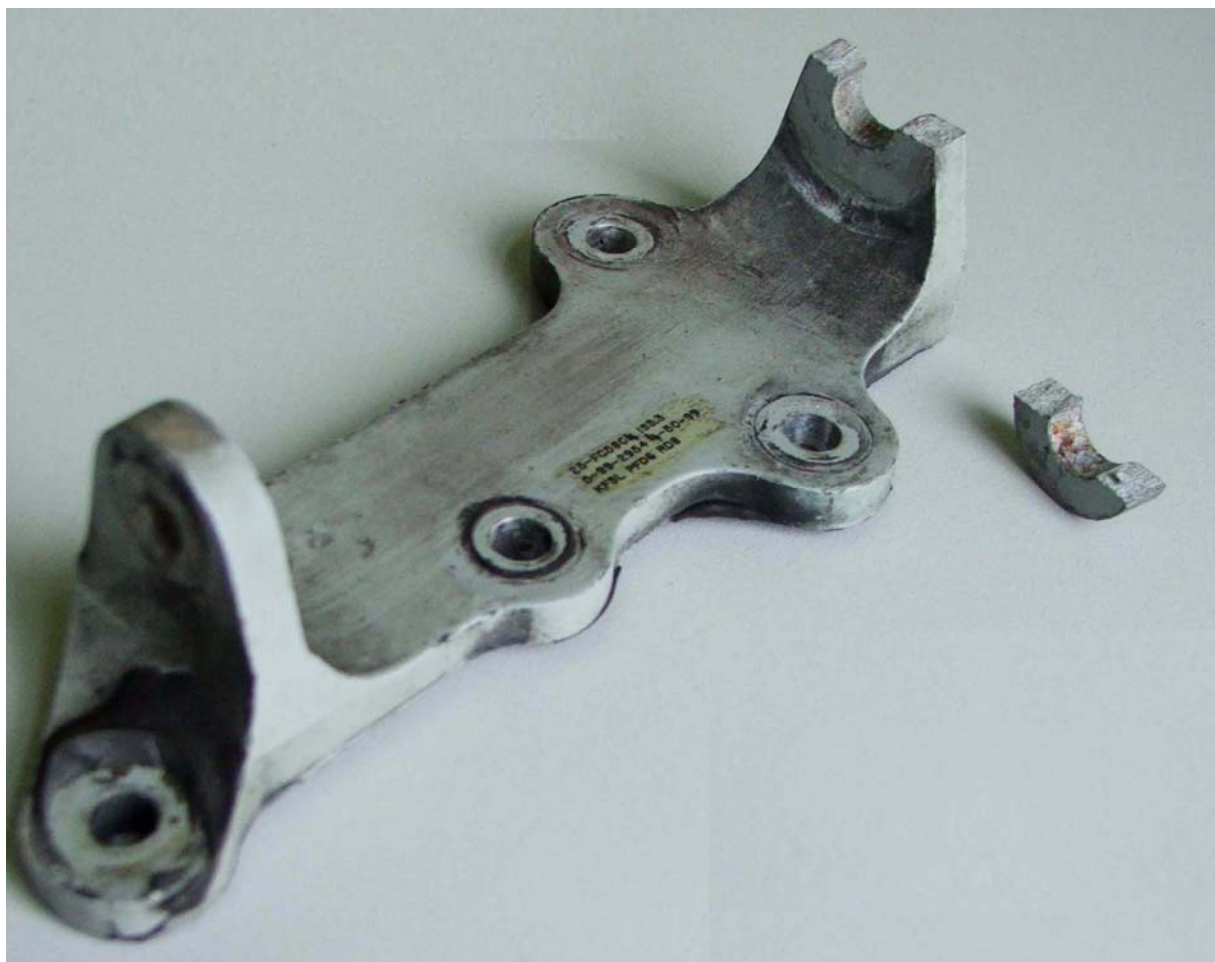
Hawker: 800XP; Cracked MLG Door Bracket; ATA 5280

A general aviation submitter writes, "During base maintenance, (we) found the R/H main landing gear door support cracked (P/N 25FC5804)."

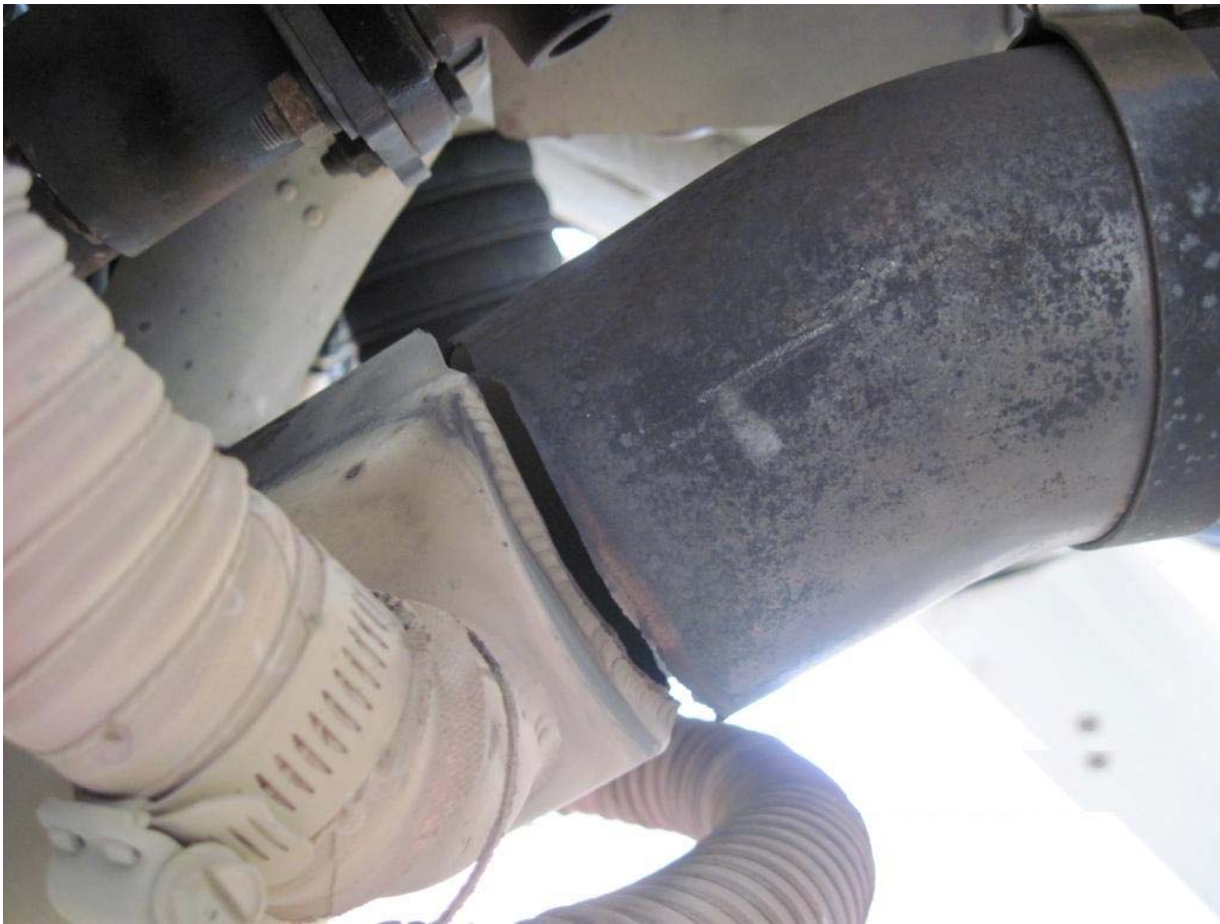
Continental: IO550N; Cracked Exhaust; ATA 7810

A repair station mechanic says, "This aircraft has a Tornado Alley Turbo normalizing system, installed under STCs SA10588SC and SE10589SC. When the cowling was removed for an unrelated issue, the right tail pipe was found cracked completely in half along the forward edge of the cabin heat exchanger weldment. It is not rare for cracks to be found along the heat exchanger in this type of tail pipe design. Undetected, the crack will eventually propagate around the tube. There is also potential for the crack to compromise the heat exchanger, possibly allowing exhaust gasses to enter the environmental system. Complicating this failure, this aircraft also had a major fuel leak, as detailed under report number 2012FA0000689. This fuel leak could have been ignited by the exhaust gasses entering the cowling from the fracture. Note: there is an improved designed tail pipe available from Tornado Alley—it is recommended any cracked tail pipes not be welded (as has been seen on other aircraft). The (tail pipes) should be replaced with the new design."

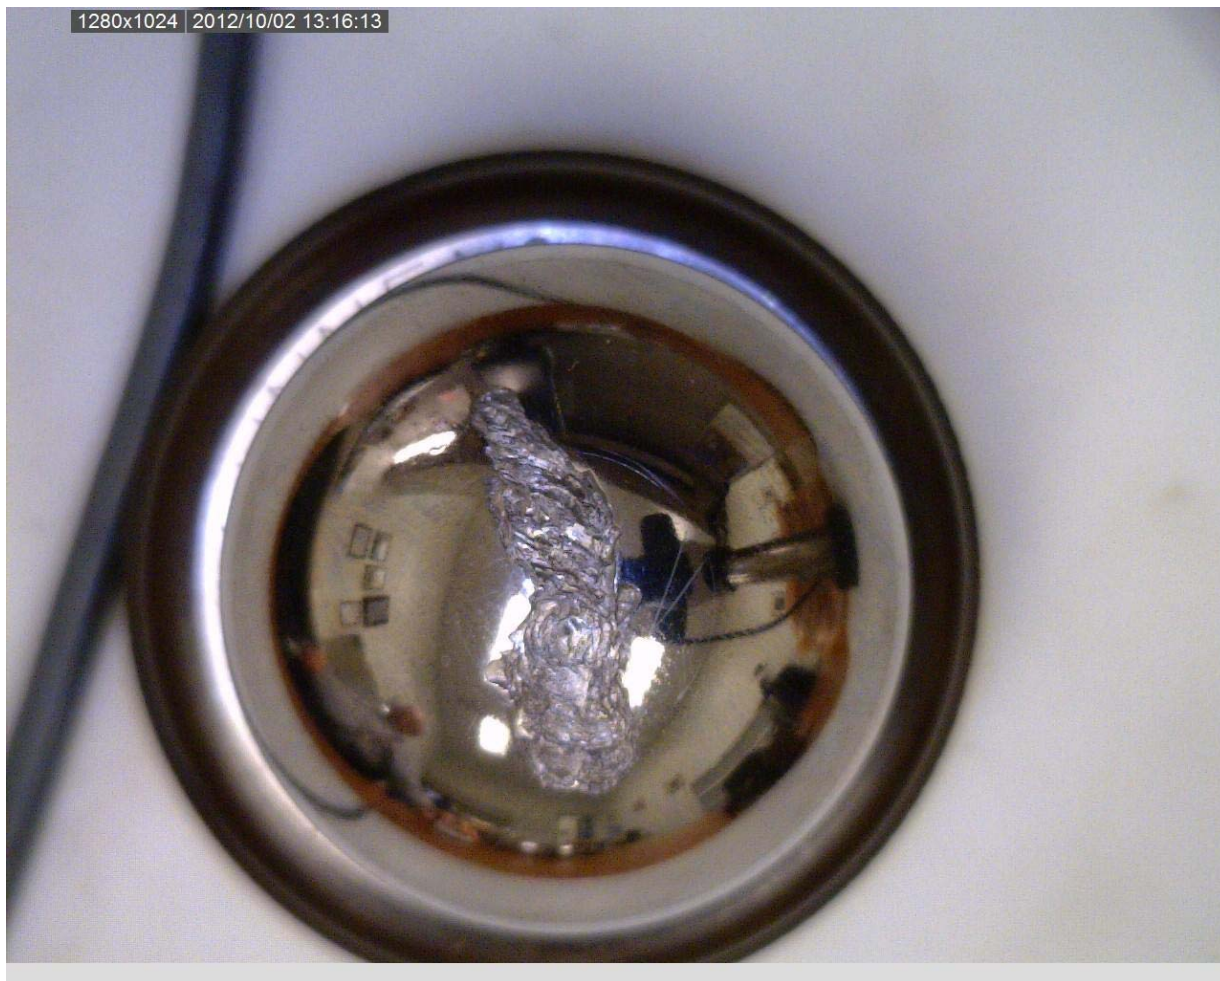
IAE: V2533A5Q03; Spalled Bearing; ATA 7200

A corporate technician states, "This bearing (*assembly?*) was sent to (*a*) repair station for inspection and possible repair. The (*repair station's*) inspector observed severe spalling on one of the bearing balls." (*Ball bearing P/N: SA7968. Alright—I confess! Were it not for this incredibly trick photograph I probably would have selected a different submission—Ed.*)

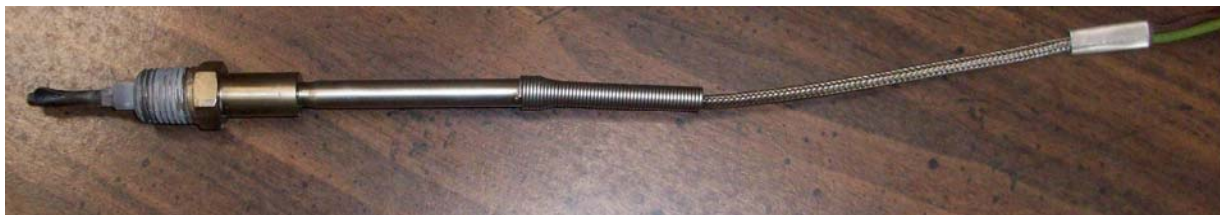
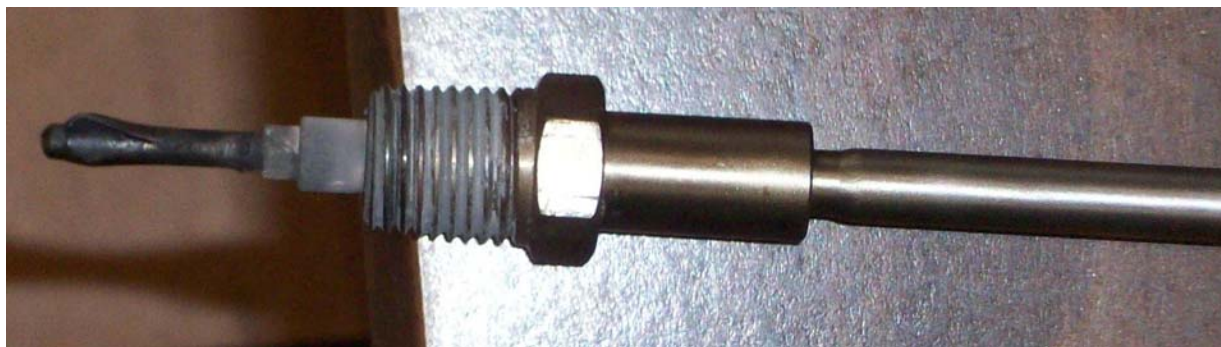
Lycoming: TIO540AE2A; Broken TIT Probe; ATA 7722

"While troubleshooting a 'No TIT' indication," says this mechanic, "the TIT probe (*turbine inlet temperature*) was found split open at its end. This probe was replaced 6 months (21 hours) ago to comply with AS2011-06-10." (*Probe P/N: 686216.*)

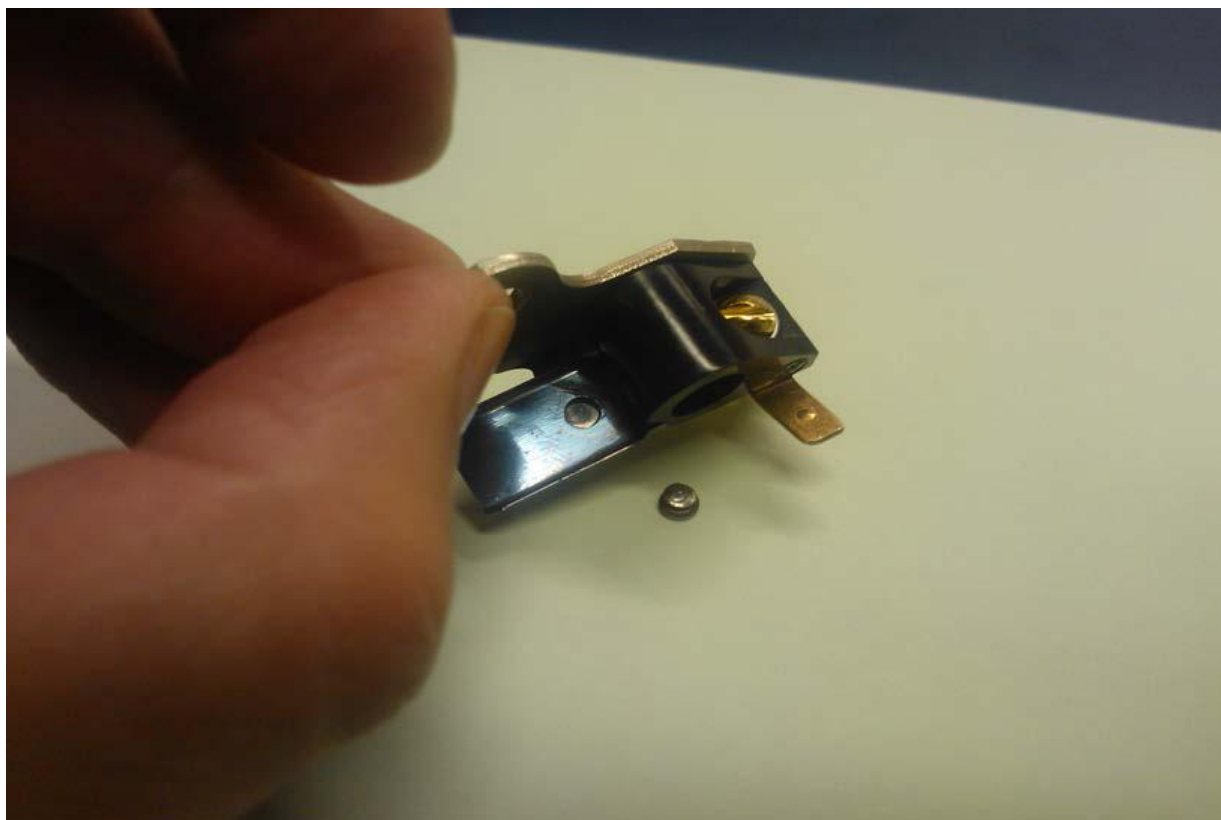
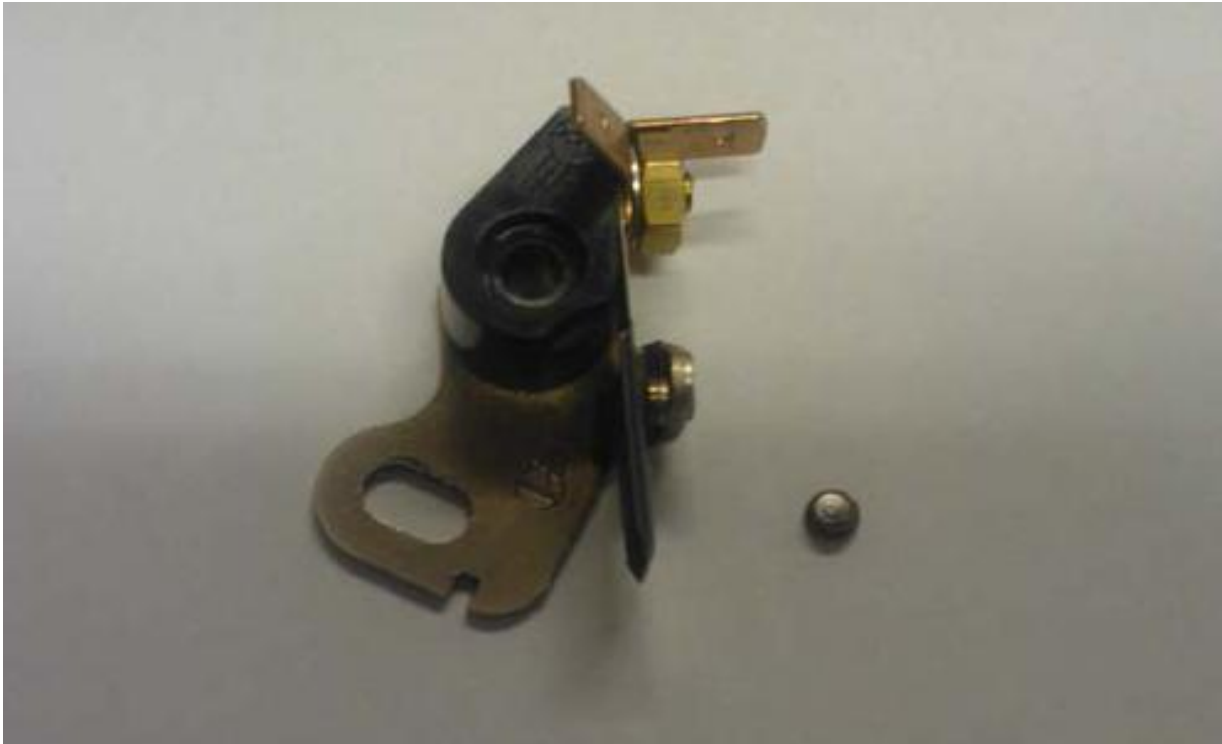
Slick Magneto: 6310; Failed Contact Points, ATA 7414

"With only 16 hours of use," says this mechanic, "the contactor pointer on the magneto separated from the contact points." (*Point assembly P/N M3081 is found in the SDRS database 23 times. Magneto number 6310 is found 36 times.*)
