**Federal Aviation
Administration**

ADVISORY CIRCULAR

AVIATION MAINTENANCE ALERTS

**ALERT
NUMBER
412**

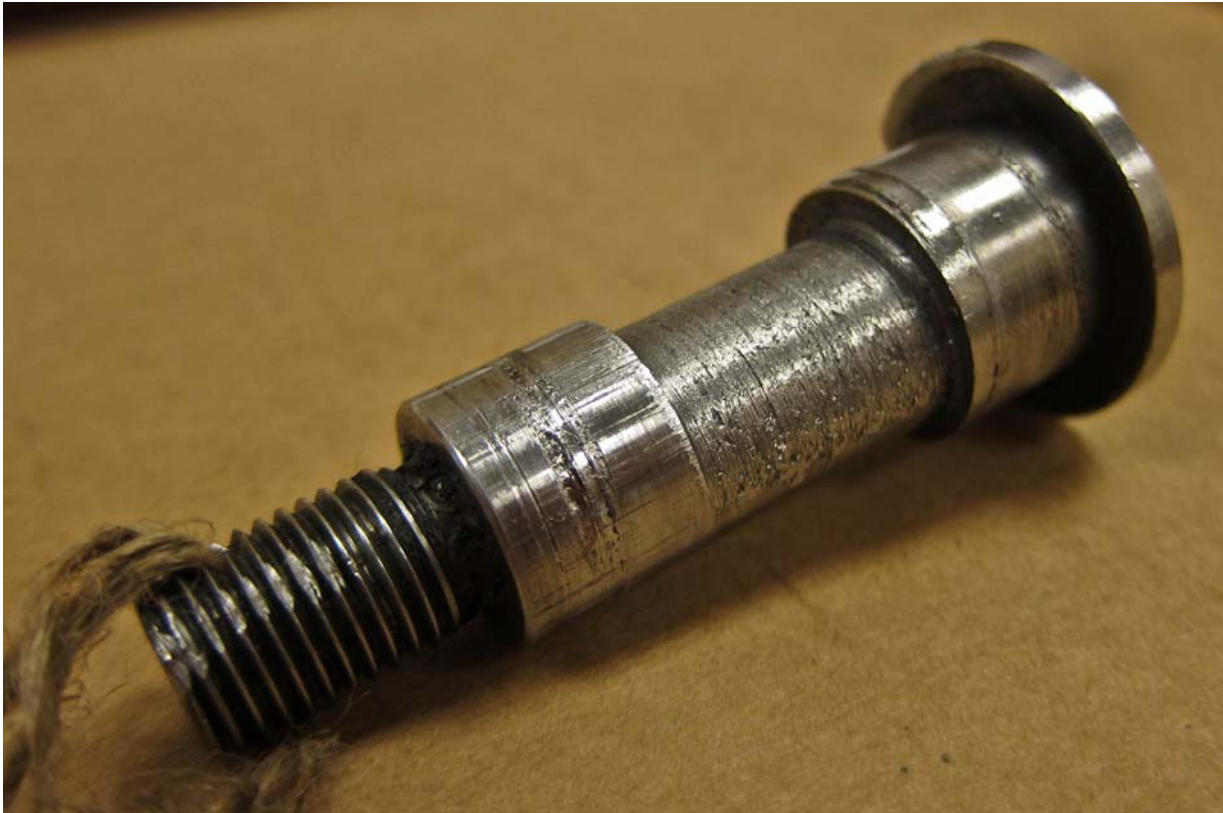
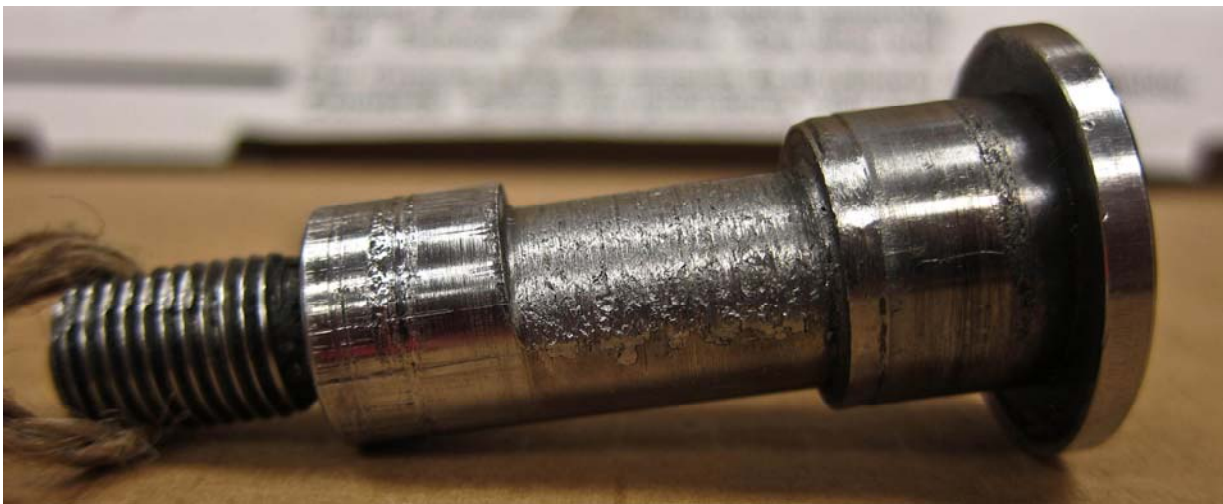
Hawker: 800XP; Cracked MLG Door Bracket; ATA 5280

A general aviation submitter writes, "During base maintenance, (we) found the R/H main landing gear door support cracked (P/N 25FC5804)."
